A.4 Côte d'Ivoire – 2010–2011 – Post-election Crisis

A.5 Côte d'Ivoire – 2010–2011 – Post-Electoral Crisis

A.6 Côte d'Ivoire – 2010–2011 – Post-Electoral Crisis

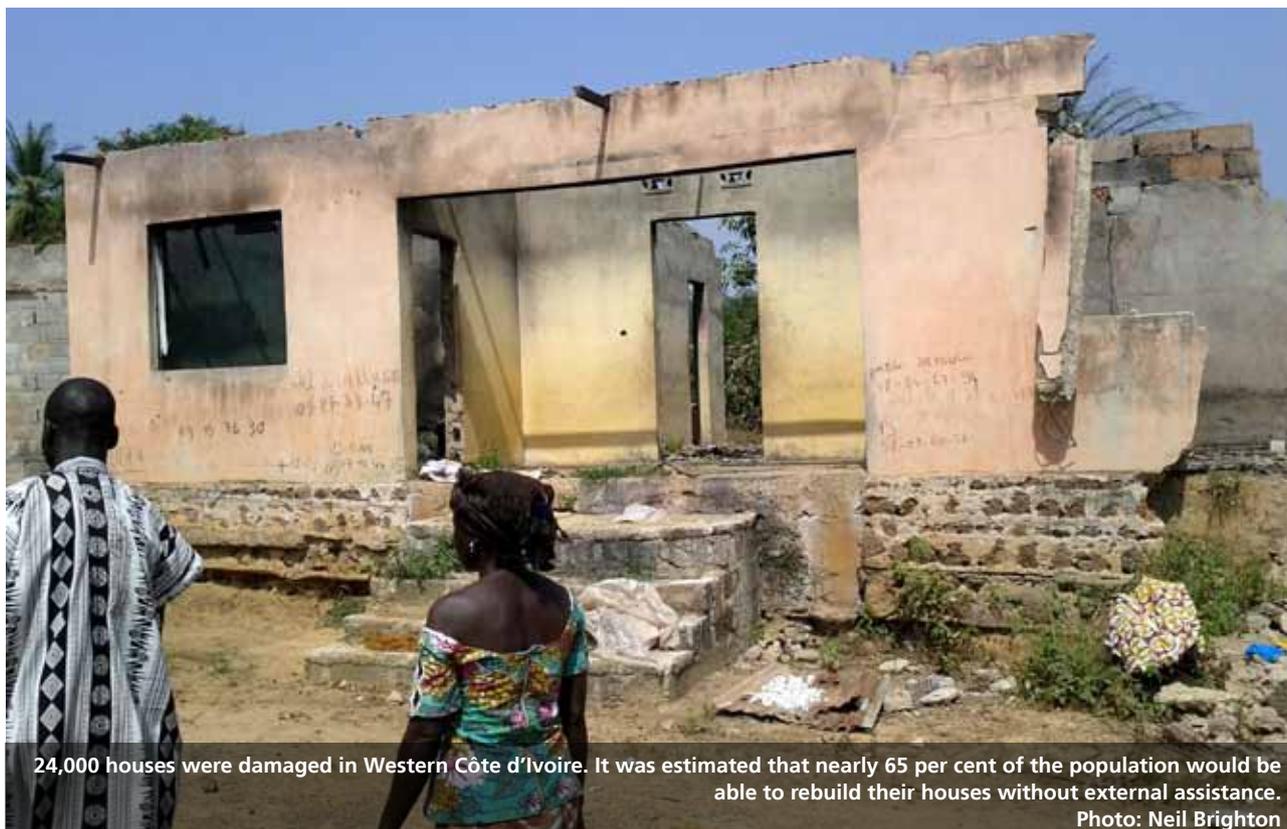
24,000 houses were damaged in Western Côte d'Ivoire. It was estimated that nearly 65 per cent of the population would be able to rebuild their houses without external assistance.

In Western Côte d'Ivoire, the vast majority of households lived in houses that are built with materials found locally and were either constructed from mud-bricks or wattle and daub. The roofs were thatched or covered in corrugated iron. Though the house walls were prone to erosion from rain and wind, and were relatively weak, they were built by the households themselves and contributed to a high self-recovery rate.

By mid-2012, the affected communities themselves had rebuilt approximately 50 per cent (11,500 houses) of the destroyed mud-brick and wattle and daub houses. This type of construction made up approximately 90 per cent of the damaged or destroyed buildings.

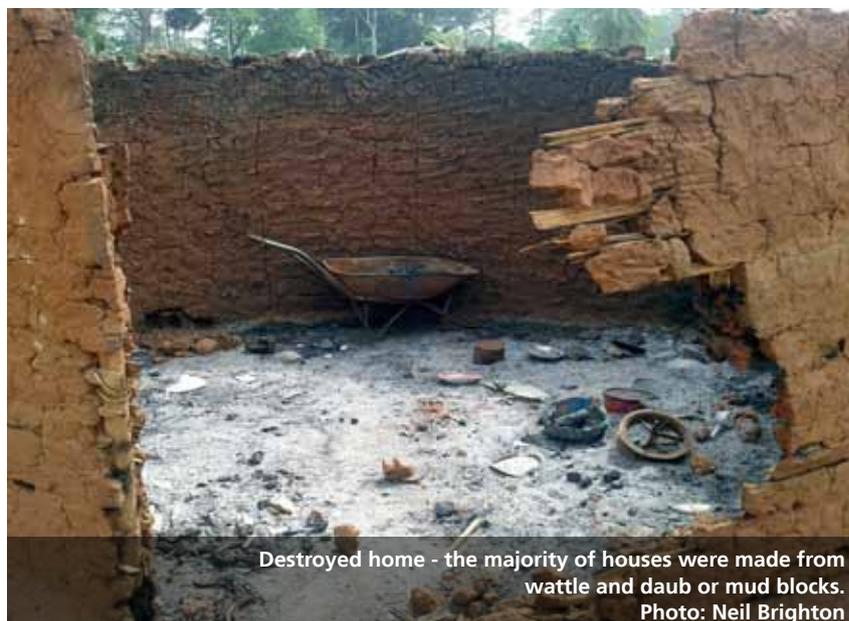
Destroyed home - the majority of houses were made from wattle and daub or mud blocks.

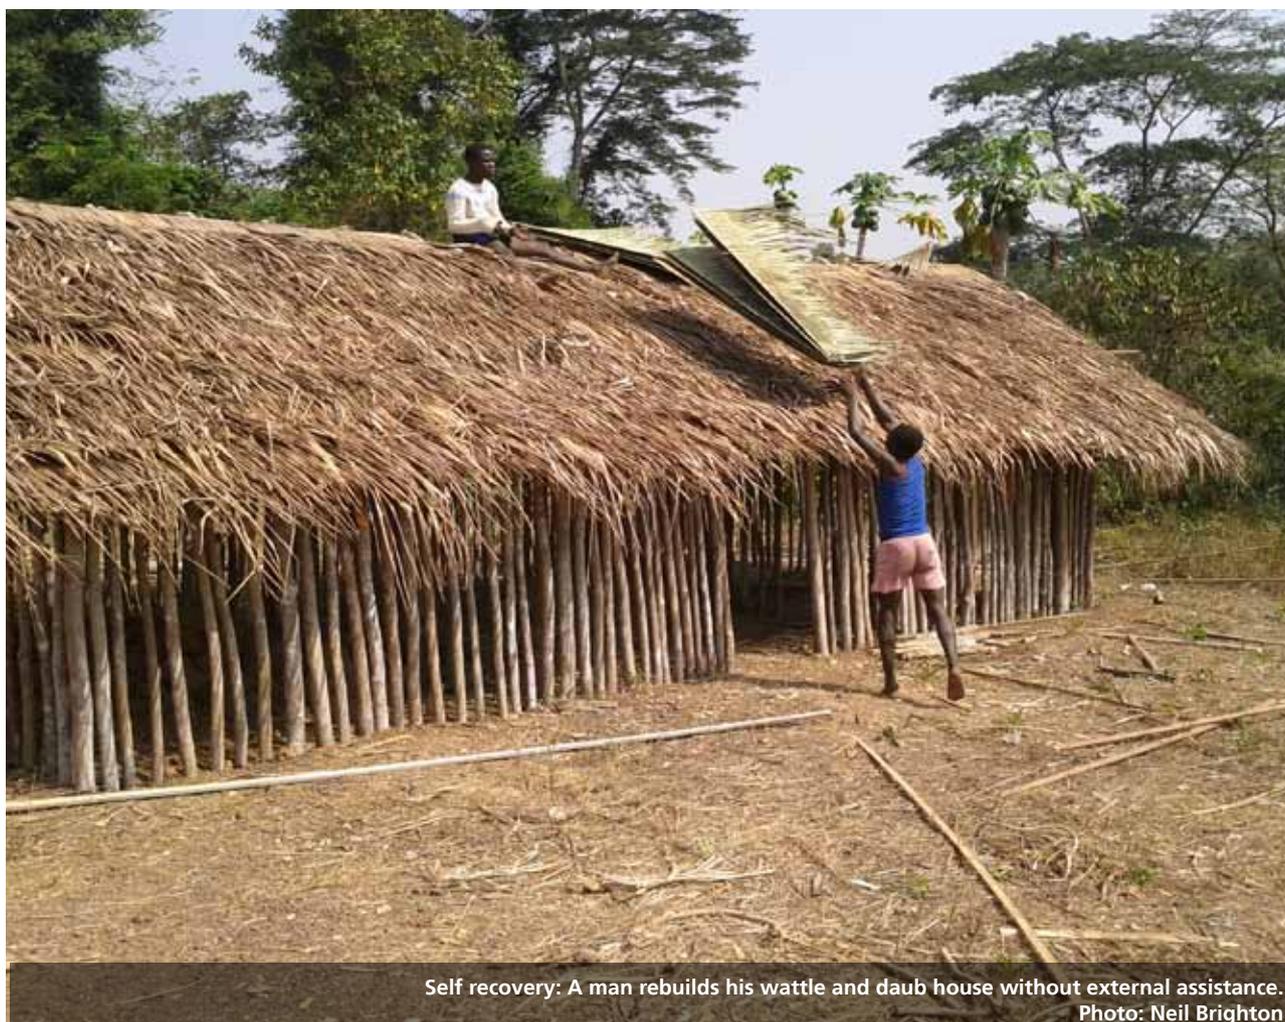
Self recovery: A man rebuilds his wattle and daub house without external assistance. Photo: Neil Brighton

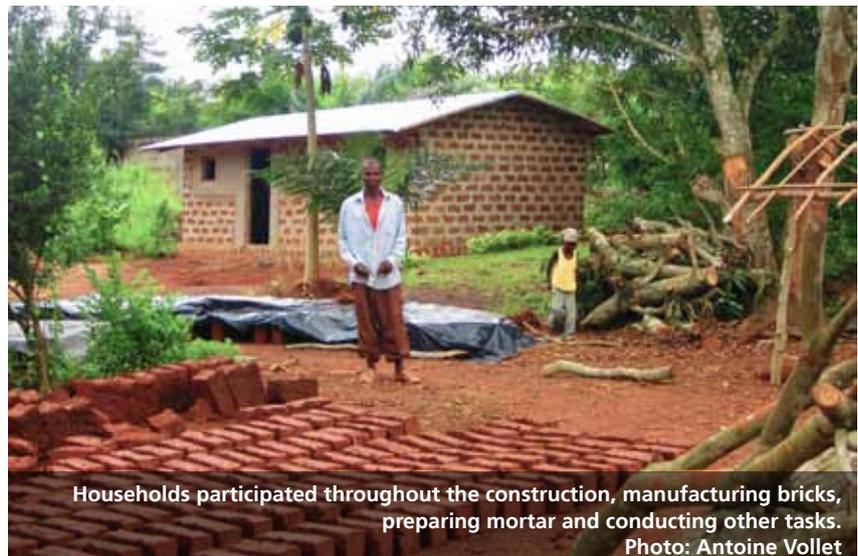
Households participated throughout the construction, manufacturing bricks, preparing mortar and conducting other tasks.
Photo: Antoine Vollet

- manufacture of mud bricks
- preparation of the mortar
- involvement throughout the construction so that they could later upgrade their houses.

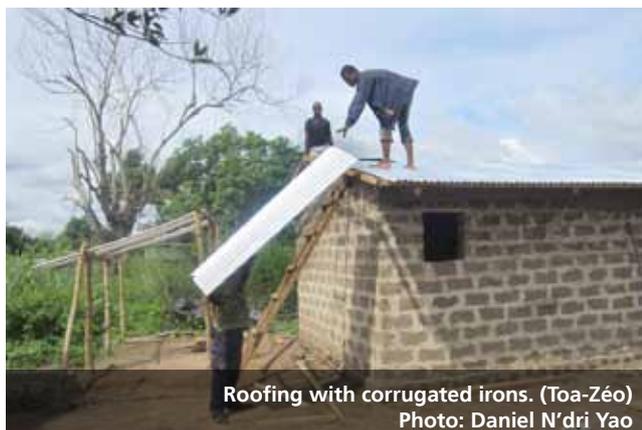
Roofing with corrugated irons. (Toa-Zéou)
Photo: Daniel N'dri Yao

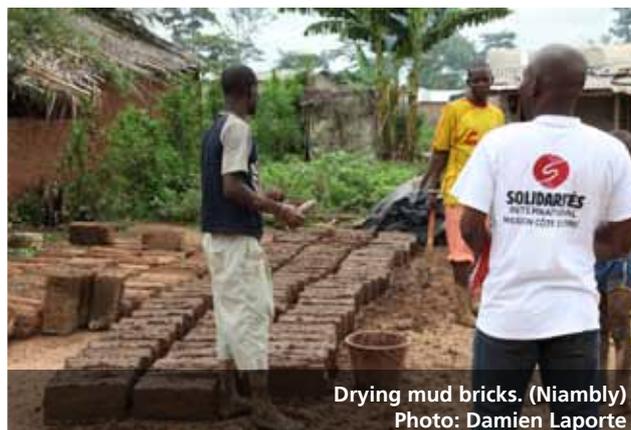
Drying mud bricks. (Niambly)
Photo: Damien Laporte

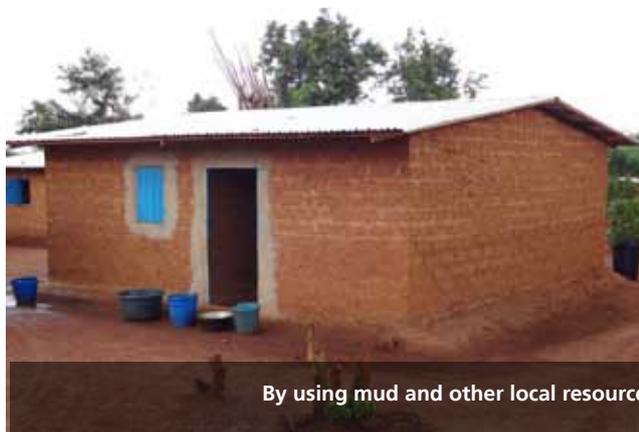
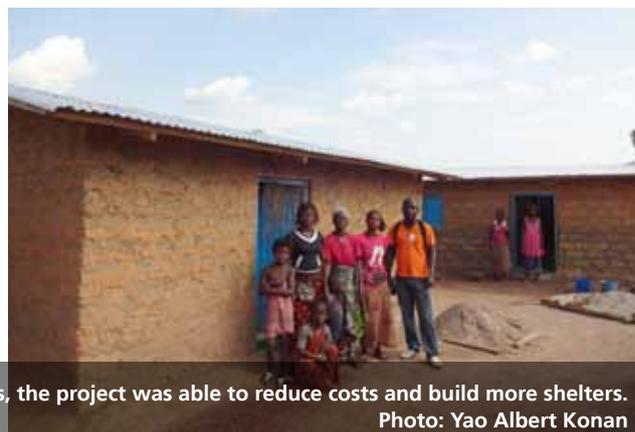
By using mud and other local resources, the project was able to reduce costs and build more shelters.

Mud bricks were selected as the easiest way to ensure a good quality of implementation, as it is a very common construction material in western Côte d'Ivoire. Cement was not used in the mortar as it would be above local standards and would increase the cost per shelter thus decreasing the number of beneficiaries.

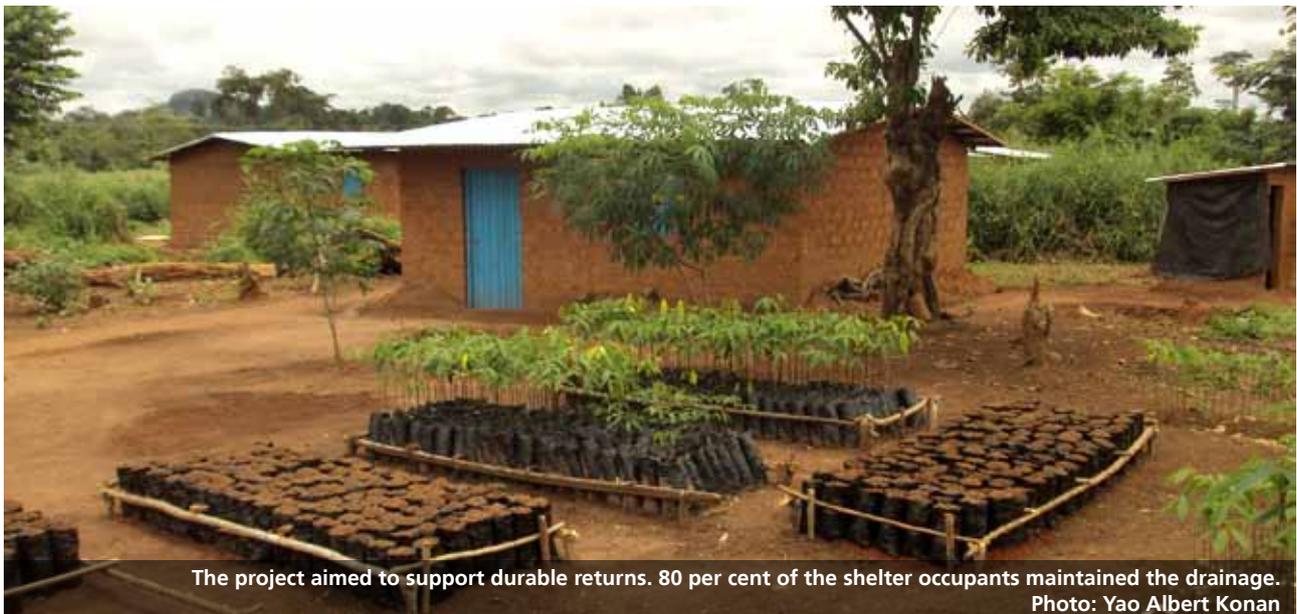
The project aimed to support durable returns. 80 per cent of the shelter occupants maintained the drainage.
Photo: Yao Albert Konan
