Open Learning School	
No. of children:	25-30
No. of carers:	4
Cost:	€26,000 (£20,000)
Area of site:	10 acres
Construction time:	4 1/2 months
Town population:	approx. 5000

THE NKORANZA CHILDREN'S
HOME, GHANA DEC 2006 - JUN 2007

article [25]
development + disaster relief

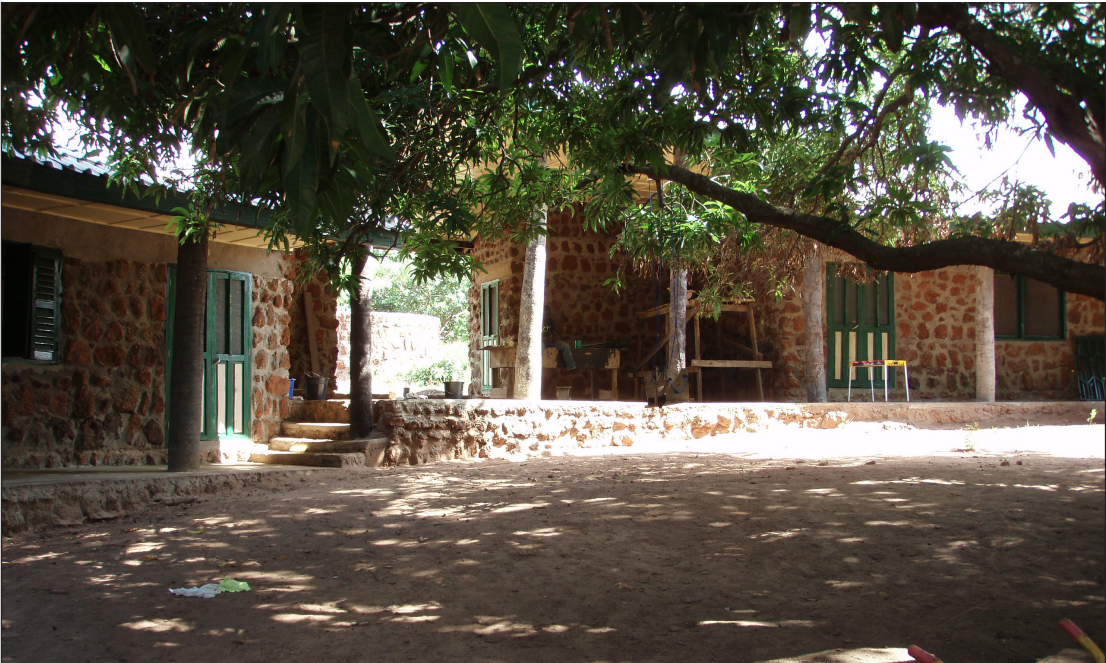
- Stone wall construction with cement mortar
- Concrete and stone foundations
- Timber roof construction with fibre concrete roofing (FCR) tiles
- Palm tree columns to support timber veranda roof structure

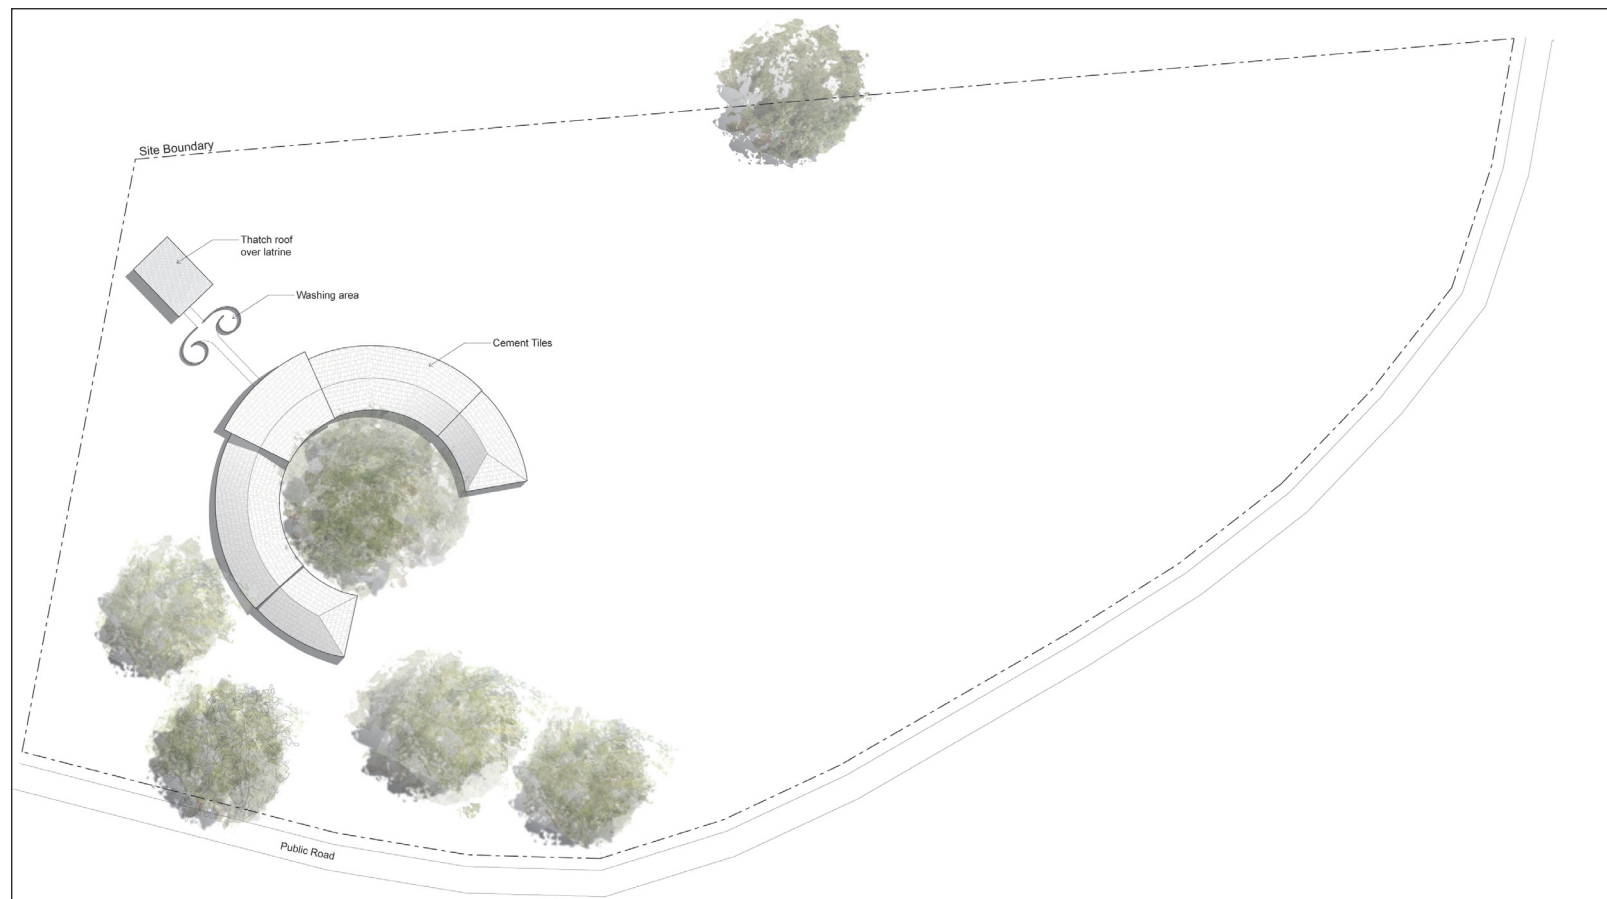
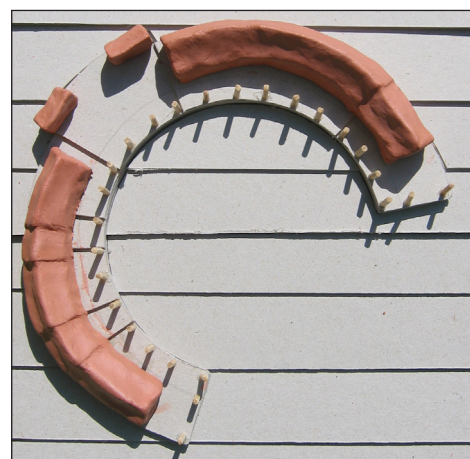
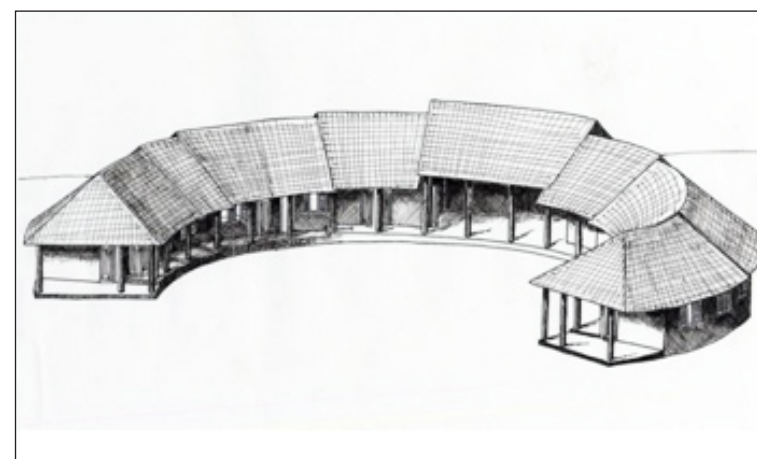
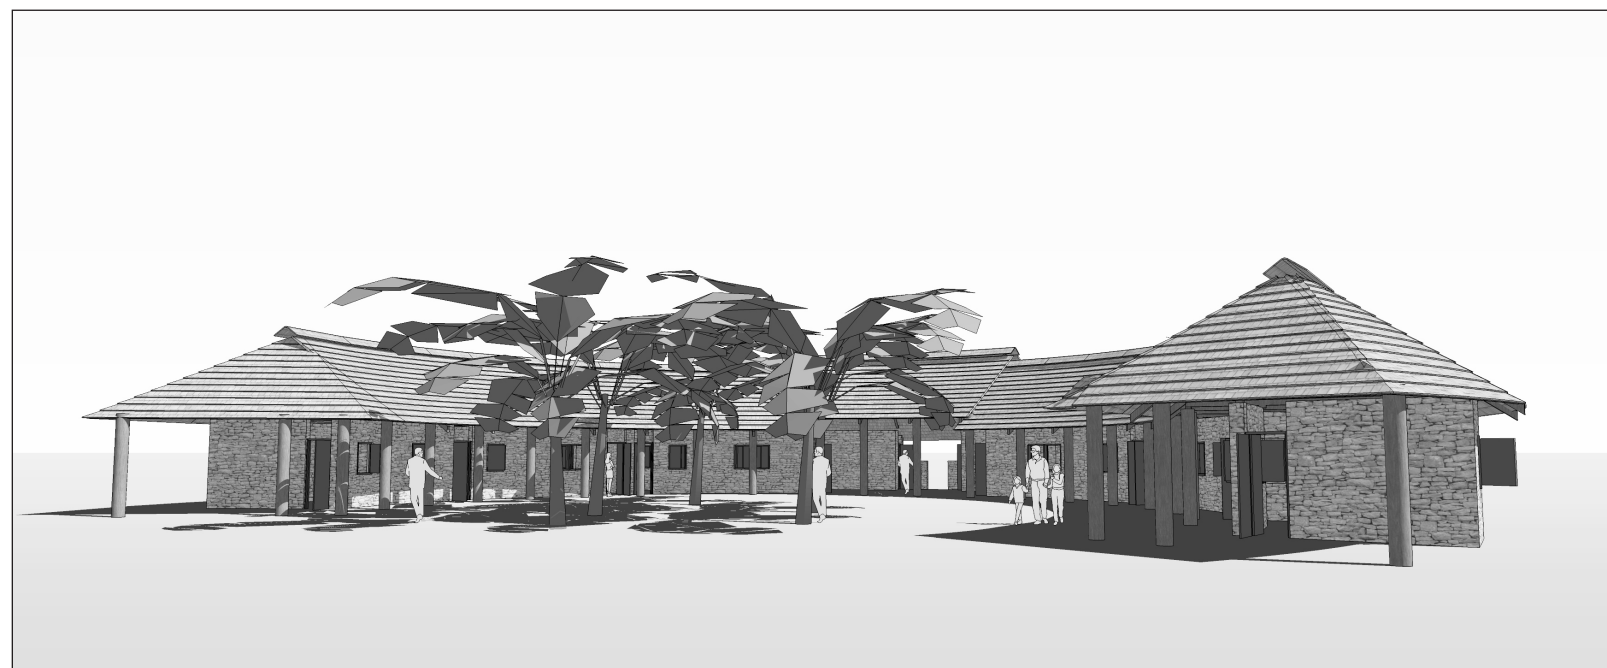
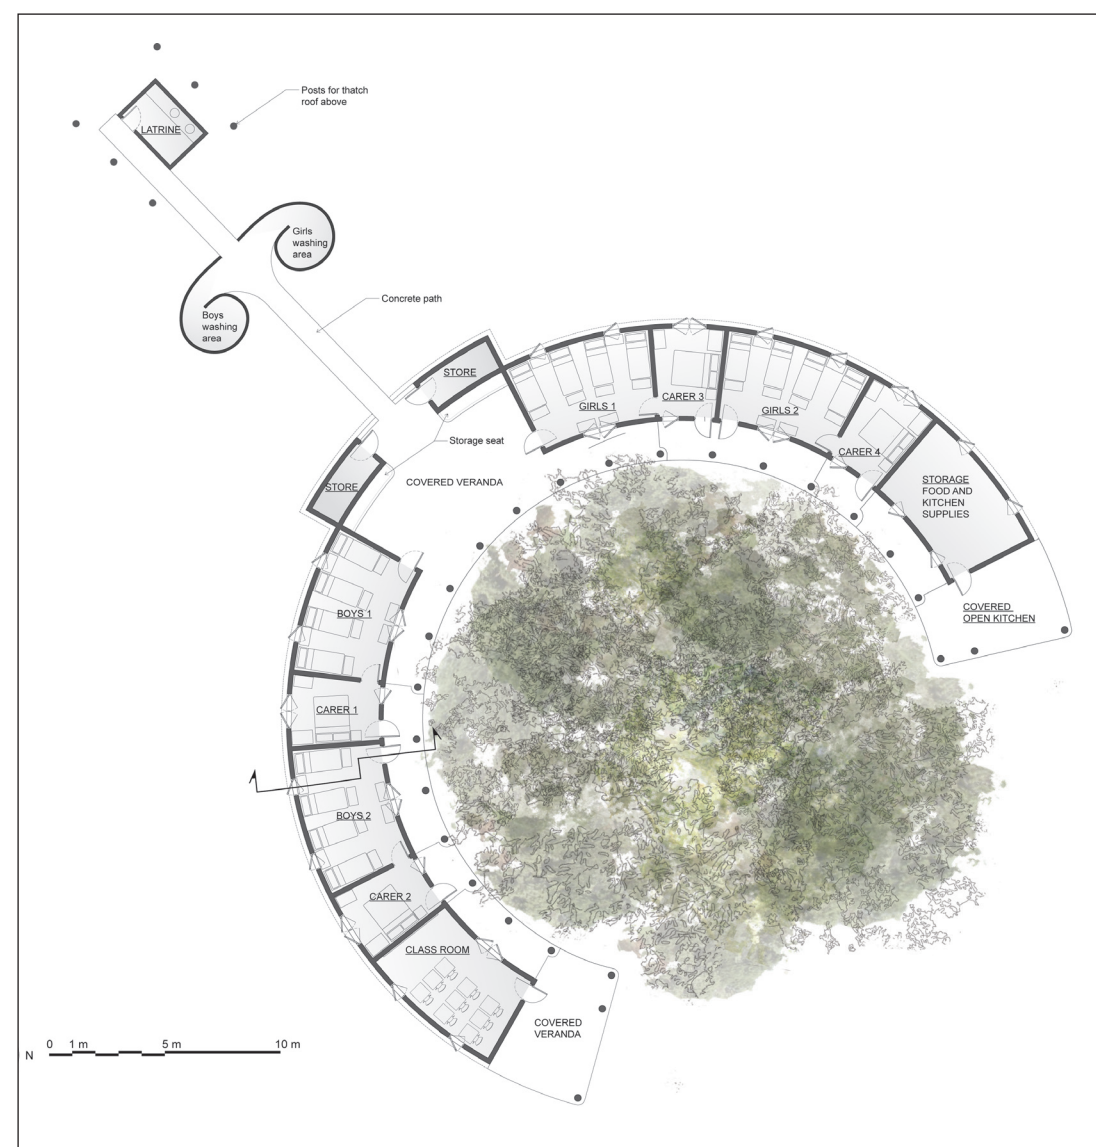
- Article 25 produced a package of drawings for the building
- Information consists of plans, sections, elevations, and details, along with two-dimensional and three-dimensional CAD models

- Appropriate detailing ensures value for money
- Details refined for maximum buildability and cost effectiveness
- Designs communicated verbally as workers found it hard to read drawings

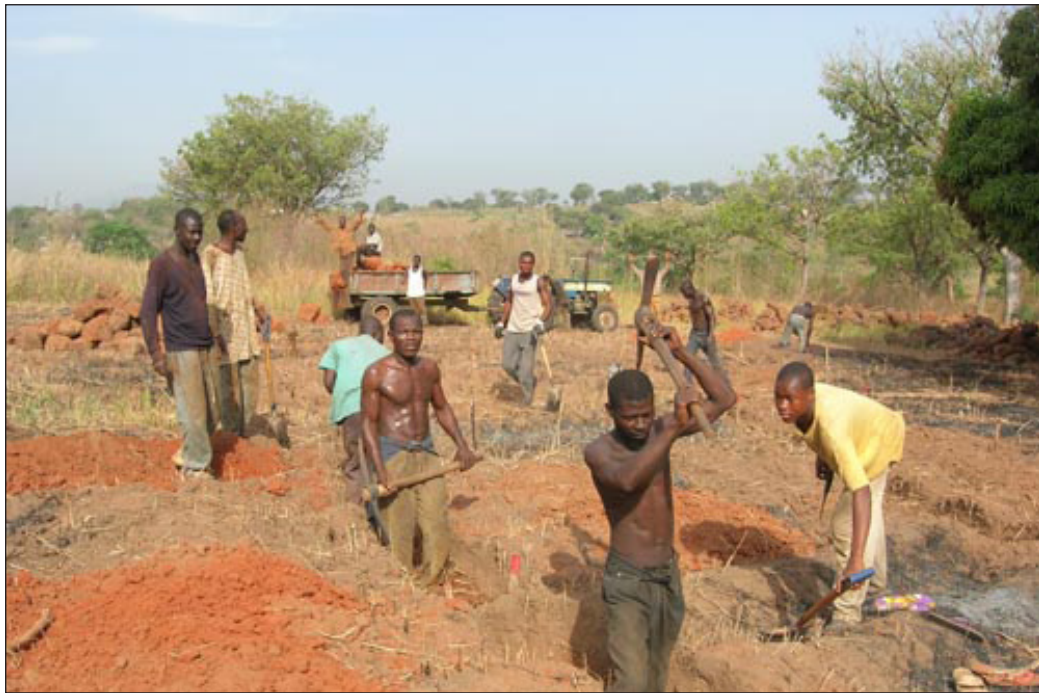
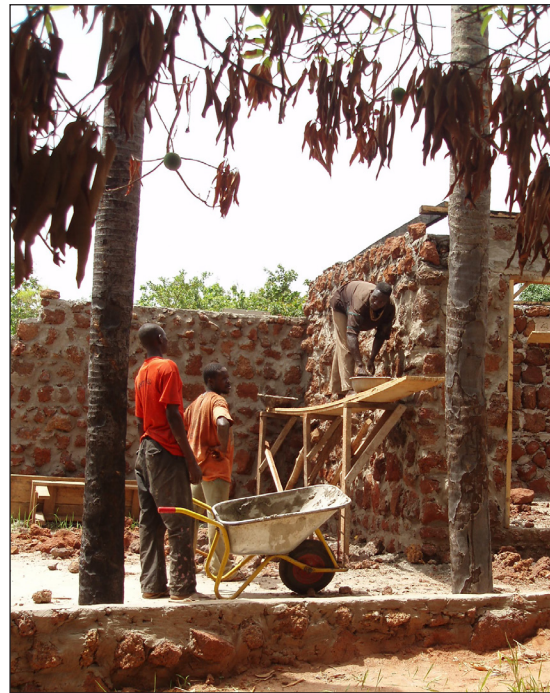
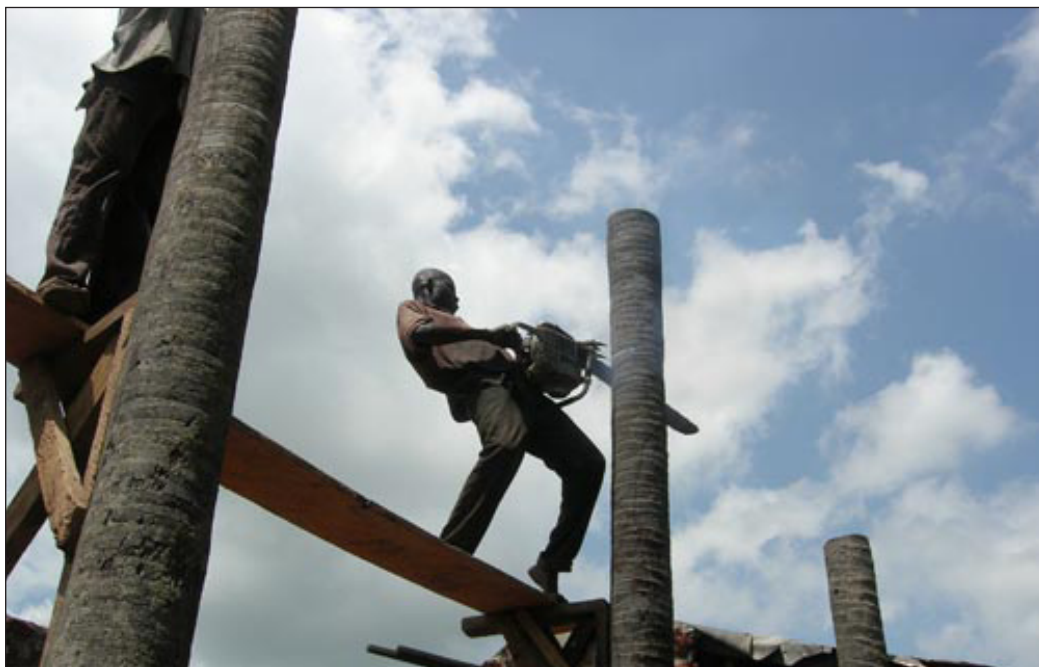
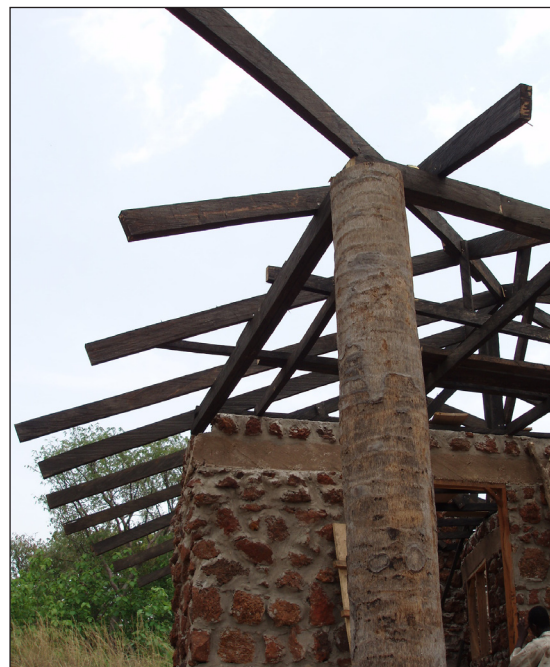
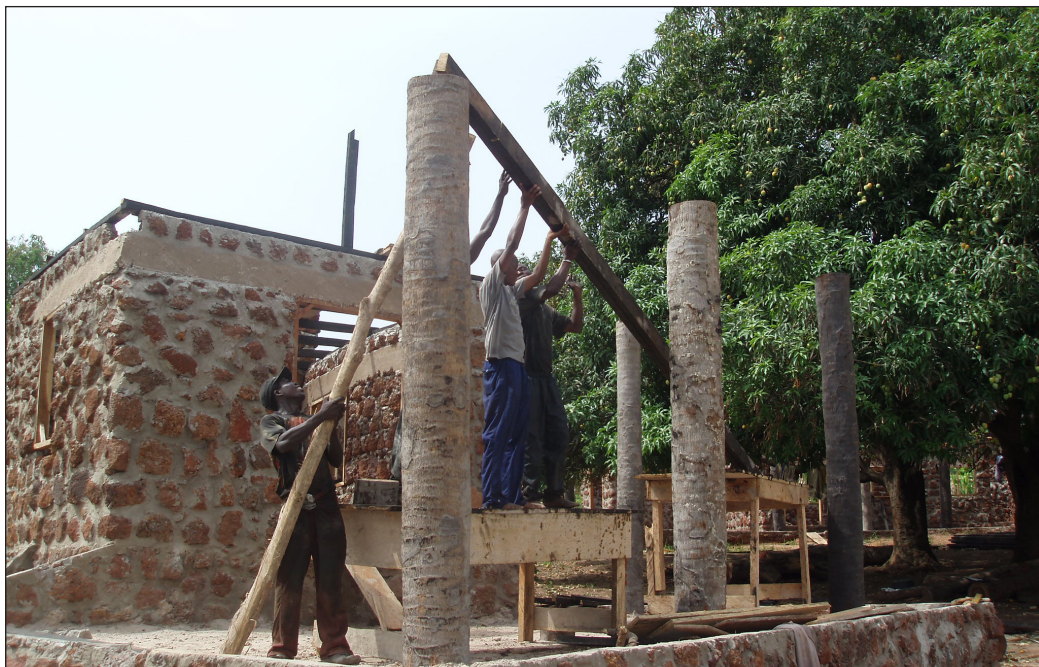
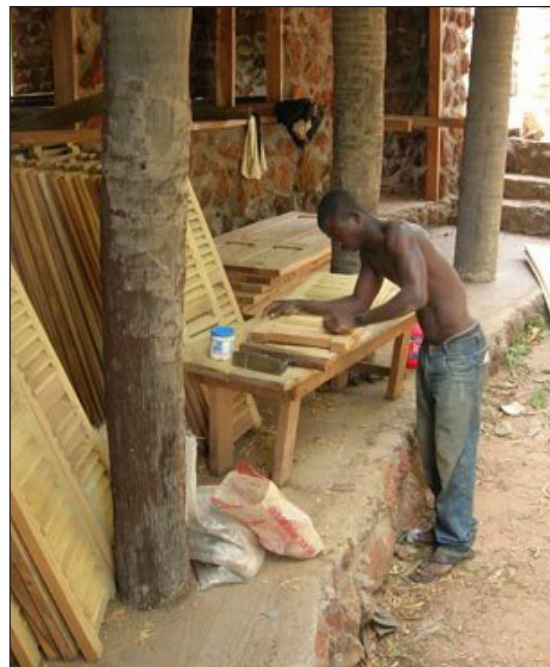
- Water pump installed on site
- Foundation trenches excavated by hand using pick axes and shovels
- Stones, sand and aggregate delivered by tractor
- Laterite stone plinth walls built off a shallow concrete liner in the trench
- Concrete mortar mixed by hand
- Plinth walls constructed up to internal floor level
- Where required plinth walls strengthened using buttresses
- Main wall construction begins
- Reinforced in situ concrete lintels poured
- Gable roof structure constructed
- Roof felting installed, followed by roof tiling
- Eaves sealed and mesh installed
- Veranda slab poured
- Latrine dug and lined with concrete block work
- Electrical fix completed
- Ceiling frame completed and ceiling fixed
- Shutters and doors fitted
- Plastering applied internally
- Pouring of concrete screed floors
- Walls painted internally
