Study Report

SR370 [2017]

# BRANZ 2015 House Condition Survey: Comparison of house condition by tenure

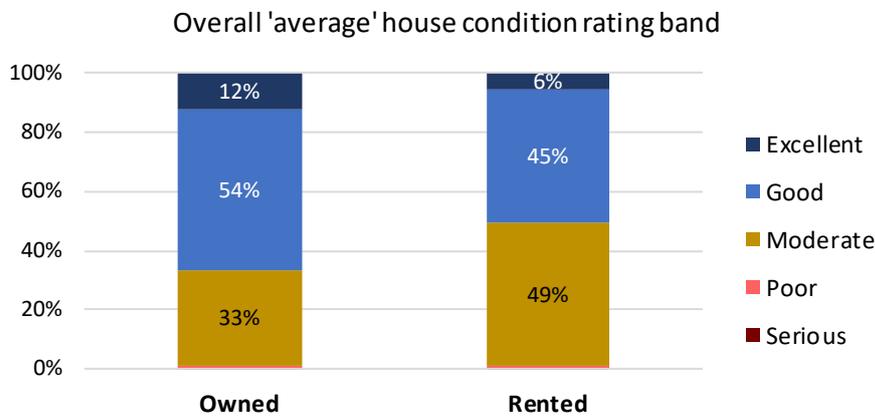
The results suggest that on average the rental housing stock is in poorer condition than the owner-occupied sector. Around half (49%) of rental properties had an average condition rating of moderate overall, compared to one third (33%) of owner-occupied houses (Figure 6). Moderate condition in the context of the HCS means the house will need attention within the next 2 years.

**Figure 6. Overall average house condition ratings banded, by tenure type. (Source: HCS 2015. Percentage sum errors due to rounding)**

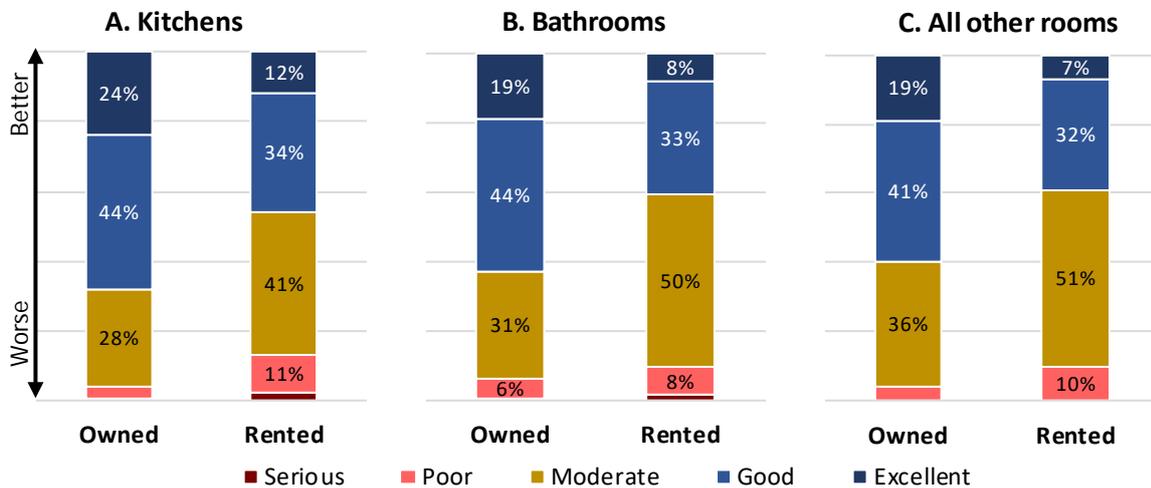
The physical house assessment part of the HCS asks the assessor to rate the condition of individual rooms in the house (specifically the kitchen, bathrooms and all other rooms). The results show the rental sector consistently has a higher proportion rated as moderate or worse condition (in need of attention within the 2 years, or sooner) compared to owner-occupied properties (Figure 10). Over three-fifths (61%) of 'all other rooms' in rented houses were rated as moderate or poor condition, compared to 40% of other rooms in owner-occupied houses. Of all room types given a condition rating, kitchens were typically rated the highest. Owner-occupied houses dominate this trend, with twice the proportion rated as excellent compared to rental properties. Likewise, over twice the proportion of bathrooms were rated as excellent in owner-occupied properties than rented properties.

Figure 10. Condition rating of rooms overall. (Source: HCS 2015)

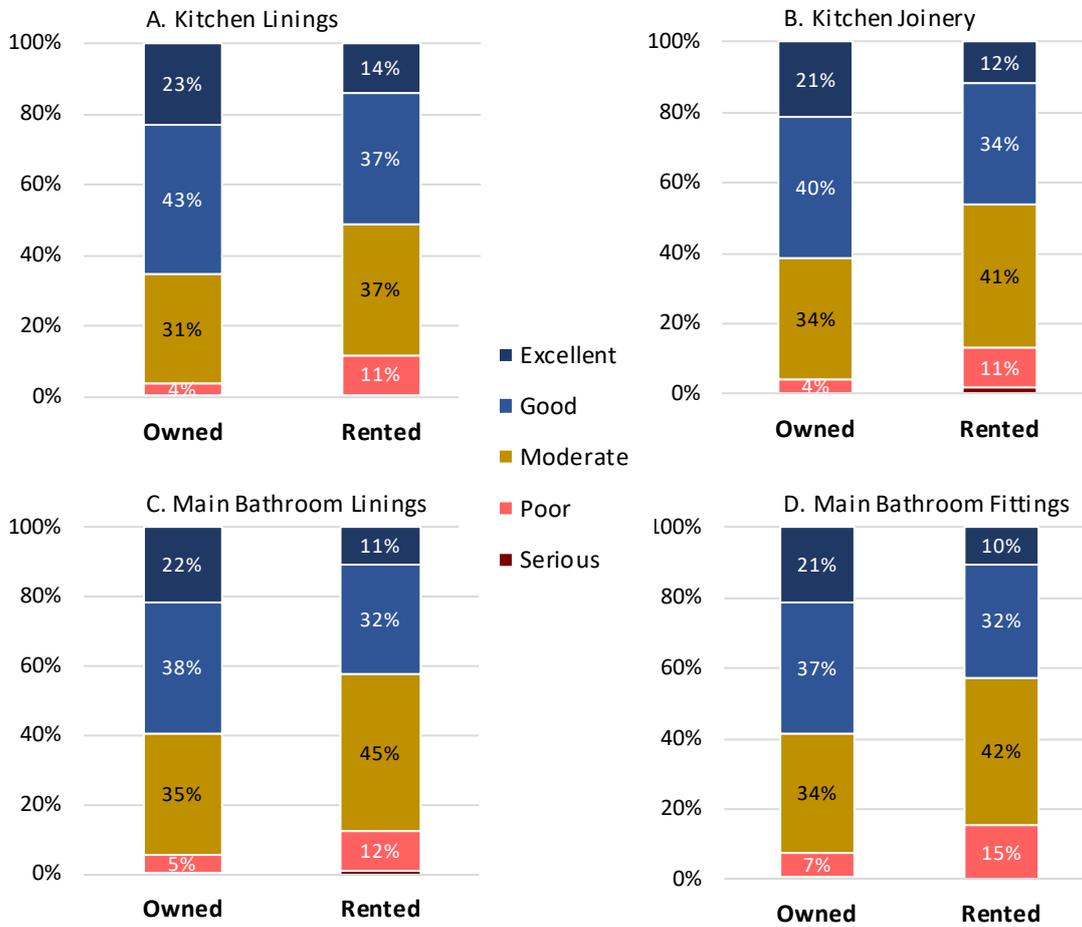
Though low in proportion, serious condition means these features pose health and safety implications and are in need of immediate attention.

Figure 11. Condition of interior linings and fittings in the kitchen and main bathroom of owner-occupied and rented houses. (Source: HCS 2015)

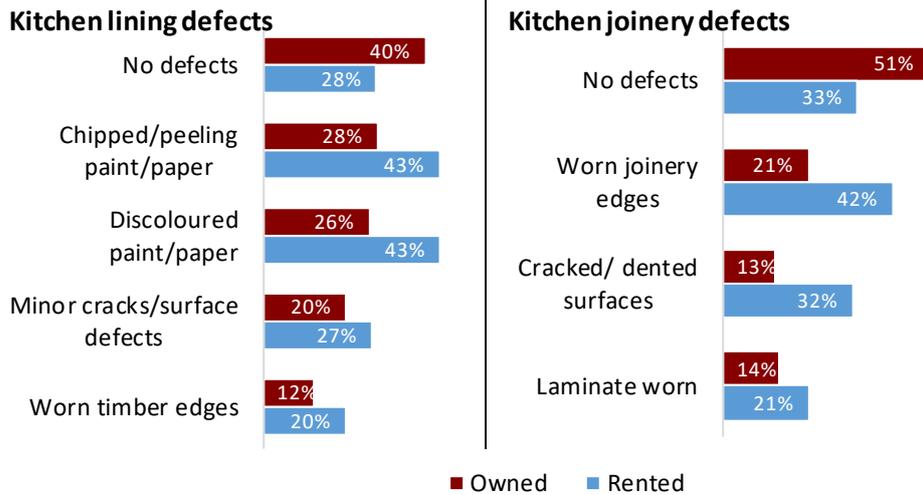
Chipped/peeling paint or wallpaper and discoloured paint/paper were present in 43% of rental property kitchens, compared to 28% and 26% of owner-occupied houses (Figure 12). Over half (51%) of owner-occupied kitchens had no joinery defects, compared to only one-third (33%) of rentals. The higher prevalence of defects aligns with the results from the overall condition assessment of the kitchen, which was lower in rentals (Figure 10).

**Figure 12. Most commonly recorded defects with linings and joinery in kitchens by tenure type. (Source: HCS 2015)**

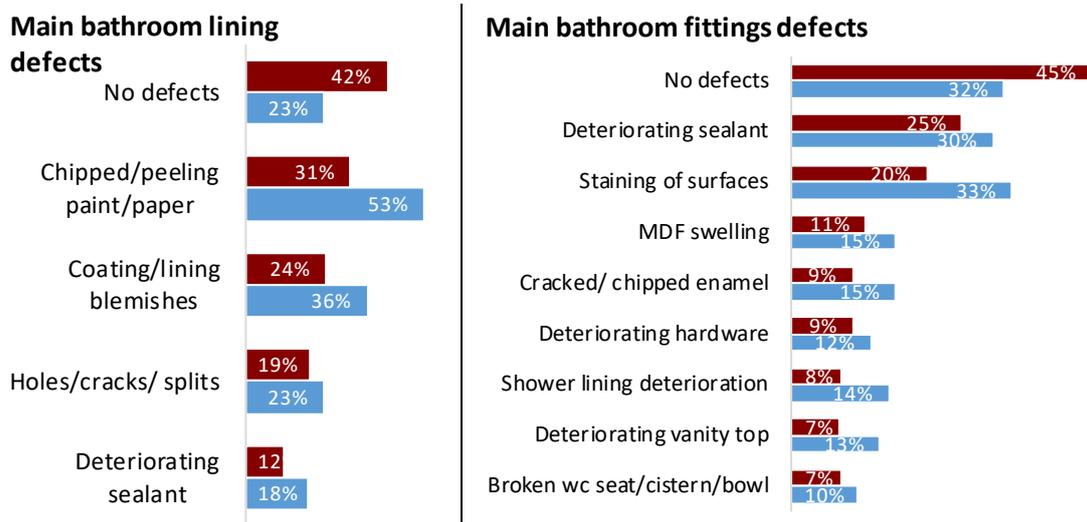
Wall linings in the main bathroom in rental properties were chipped or peeling in over half (53%) of rental properties, compared to 31% of owner-occupied houses (Figure 13). Fittings in the main bathroom of rental properties showed signs of deteriorating sealant and stained surfaces in 30% and 33% of cases respectively. 25% and 20% of owner-occupied houses showed these defects (Figure 13). MDF swelling, cracked/chipped enamel, deteriorating bathroom hardware, deterioration of the shower lining, deteriorating vanity top and broken toilet seat/cistern/bowl were also more common in rental properties. Again, the higher prevalence of defects with bathroom linings and fittings in rented houses aligns with the assessor's (lower) rating of the condition of these features and the main bathroom overall.

**Figure 13. Most commonly recorded defects with linings and fittings in the main bathroom by tenure type. (Source: HCS 2015)**

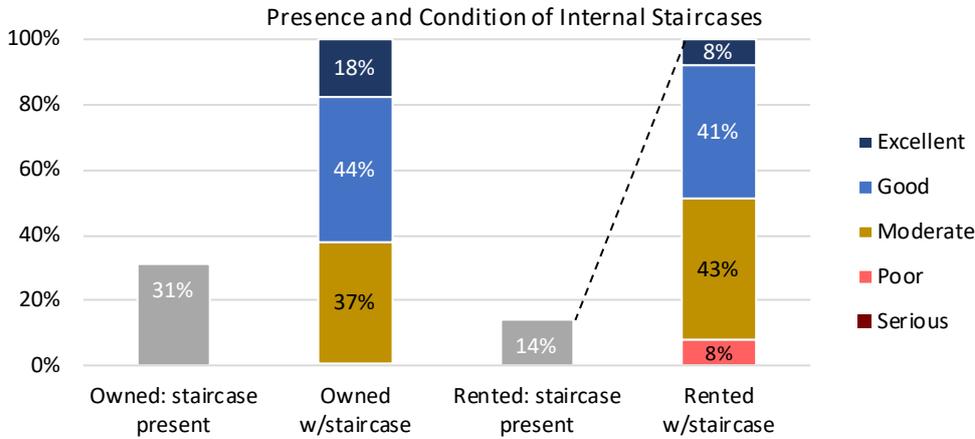
rental properties with a staircase, 43% were in moderate condition and 8% in poor condition (need attention within the next 3 months).

**Figure 14. Presence and condition of staircases by tenure type. (Source: HCS 2015)**

Common defects recorded with staircases related to handrails and balustrades.<sup>1</sup> In 17% of houses, the handrail was not continuous,<sup>2</sup> and for a similar proportion (16%) the handrail/balustrade was missing (Table 5). In rental properties, 14% of houses with a staircase did not have a handrail on one side where there was an open drop. Staircases in poor condition and with defects such as these present a potentially greater hazard and risk of trips and falls.<sup>3</sup>

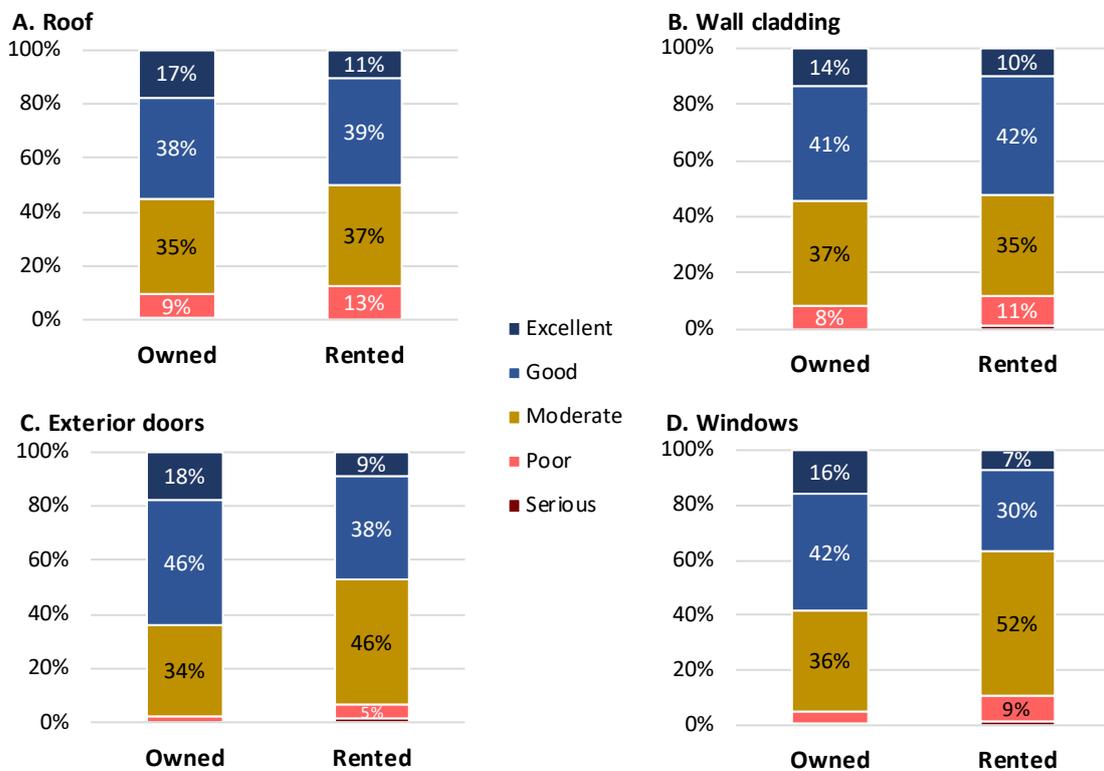
Figure 15 suggests that exterior features of rental properties were typically in slightly poorer condition than owner-occupied properties. However, the difference between the two tenures is less obvious for roofs and wall cladding compared to interior features (as shown in Figure 10 and Figure 11) and windows and exterior doors. This finding could suggest that property maintenance by owner-occupiers exceeds the rental sector for only certain features of the home, rather than across all building components.

**Figure 15. Condition rating of building envelope and key external features of owner-occupied and rental houses. (Source: HCS 2015)**

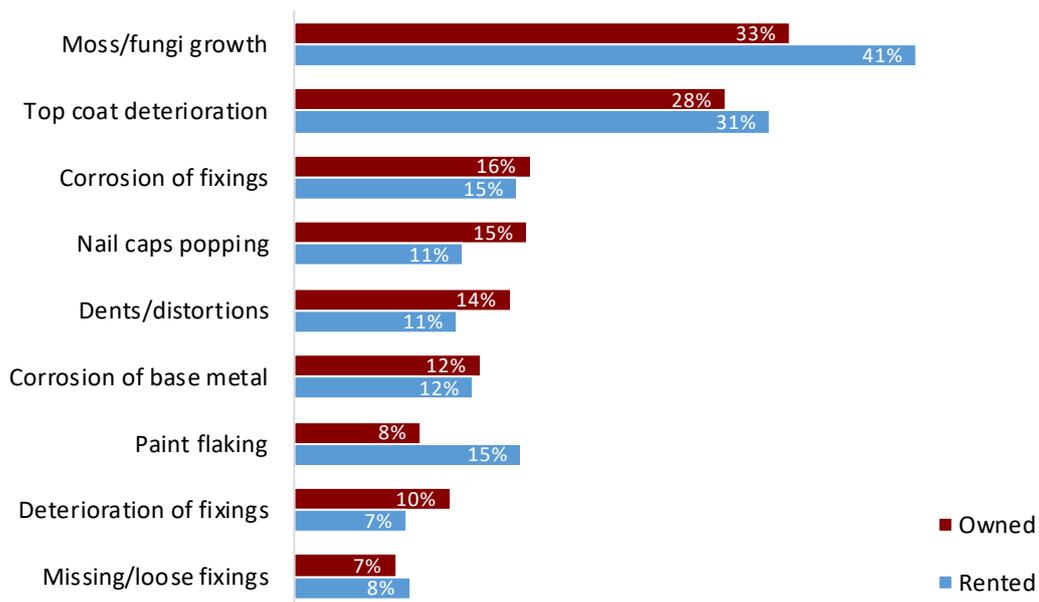
Compared to other house features, the condition of roofs showed less divergence between the owner-occupied and rental stock. This was shown in the condition ratings (see Figure 15A) and is evident in the frequency of defects recorded (Figure 16). Moss/fungi growth and flaking paint stand out as exceptions, being much more common with rental property roofs. These defects could be considered some of the more noticeable and easier to address of roof defects, hence the greater difference between the two sectors. (Owners are more likely to undertake repairs and maintenance than landlords.)

**Figure 16. Common defects recorded with roofs in owner-occupied and rented houses. (Source: HCS 2015)**

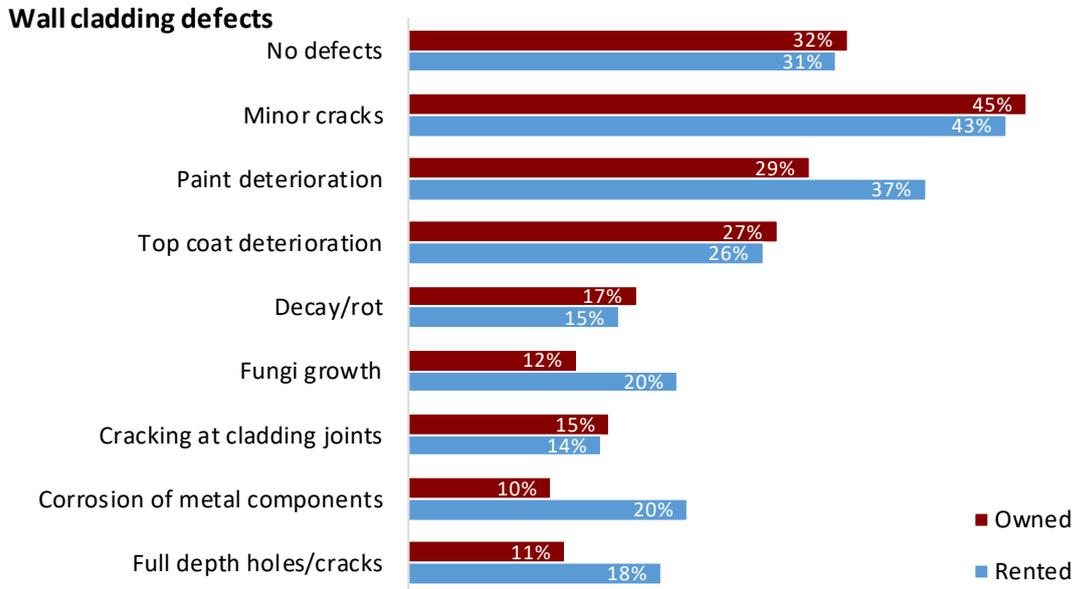
decay/rot and cracking at cladding joints affected similar proportions of owner-occupied and rented houses, but paint deterioration, fungi growth and corrosion of metal components were common in rental properties. Construction material will be an important factor here, in addition to the ability and willingness to undertake repairs and maintenance. For example, paint deterioration could be considered a more obvious and easier to address defect, hence the divergence between the two sectors.

**Figure 17. Common defects recorded with wall cladding in owner-occupied and rented houses. (Source: HCS 2015)**

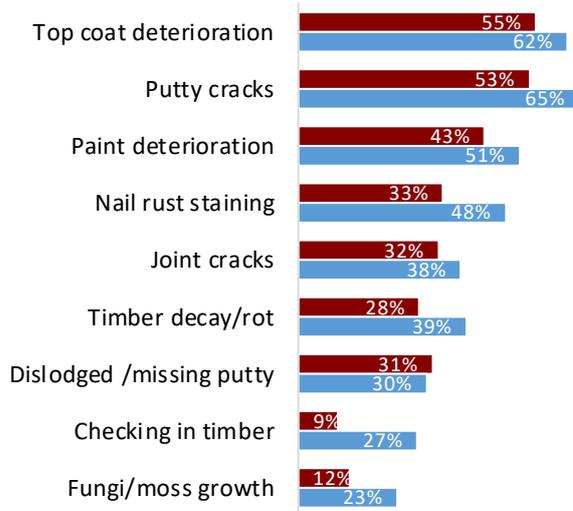
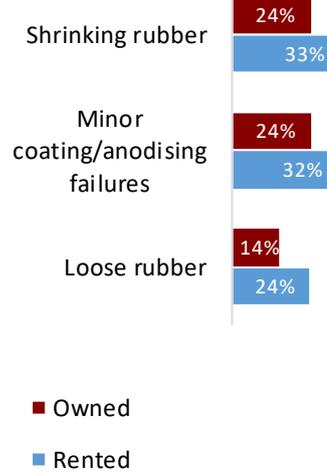
(Timber windows defects base count = houses with timber windows = 41% of owner-occupied and 43% of rented)

(Aluminium windows defects base count = houses with aluminium windows = 80% of owner-occupied and 61% of rented)

**Figure 18. Common defects affecting timber and aluminium windows in owner-occupied and rented houses. (Source: HCS 2015)**

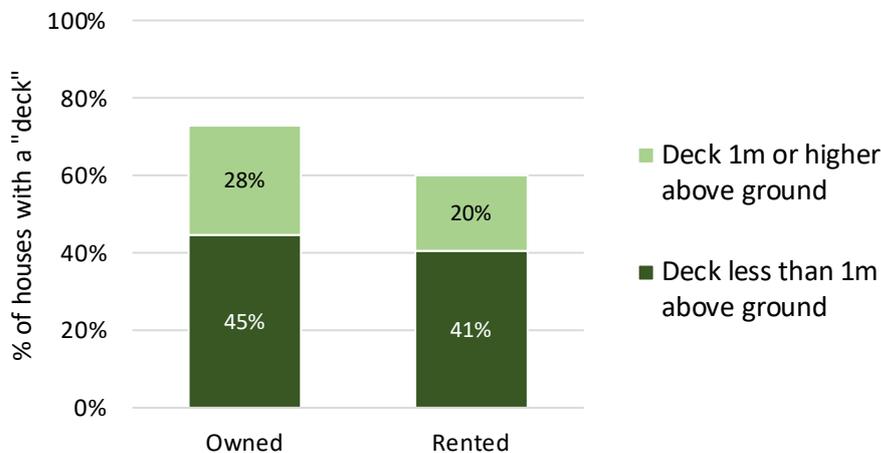
It is possible, however, to retrospectively go some way towards making this distinction, as the maximum height above ground of the deck/balcony is recorded. Overall, 73% of owner-occupied and 60% of rental properties surveyed had some data recorded about decks/balconies. However, most of these were less than 1 m above ground (Figure 19).

**Figure 19. Presence of decks and balconies by maximum deck height above ground and tenure. (Source: HCS 2015)**

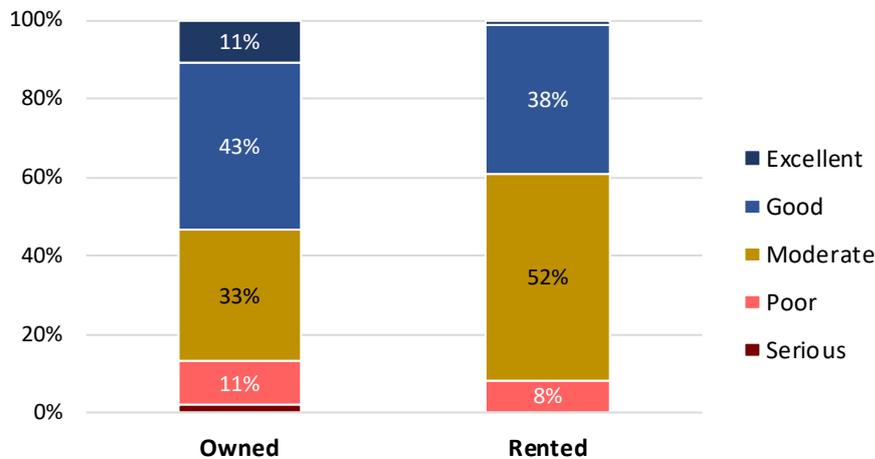
Of the owner-occupied houses with a deck, 11% were in poor condition, meaning they need work within the next 3 months. A fraction (2%) were in serious condition (need immediate attention and may pose health and safety implications (Figure 20). The height of the deck above ground (less than 1 metre or 1 metre or higher) made little difference to the condition rating of decks in owner-occupied houses.

Around half (52%) of decks on rental properties were in moderate condition. There was some difference in the condition of decks by height above ground on rental houses. Decks with a maximum height of 1 metre or more above ground were more likely to be in moderate condition than good condition. It should be noted that these figures apply to a relatively small sample – only 20% of rental properties surveyed had a deck at this height.

**Figure 20. Condition rating of decks in owner-occupied and rented houses. (Source: HCS 2015; figures as a percentage of houses that had a deck)**

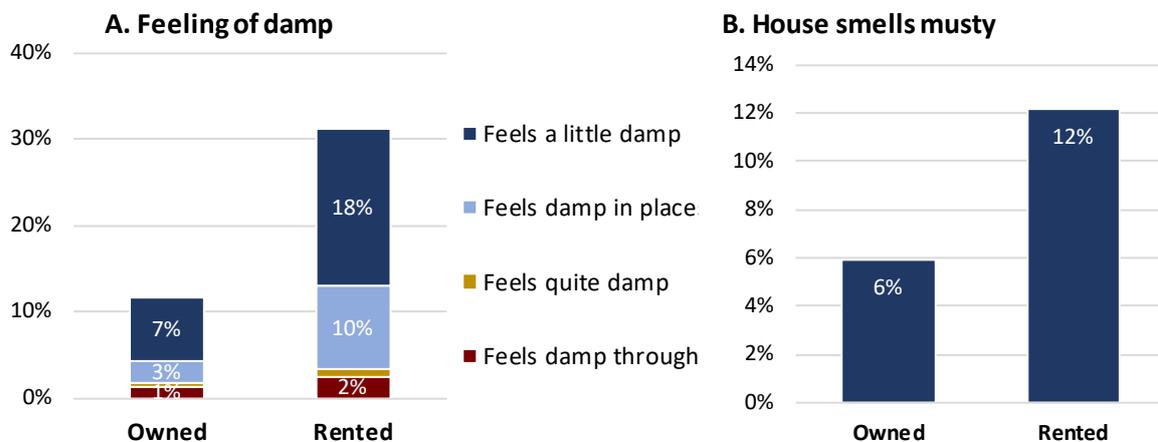
Figure 21(A) shows that 18% of rental properties surveyed felt a little damp to the assessor, a further 10% felt damp in places and 3% felt quite damp or damp throughout. This equates to a total of 31% of rental houses feeling damp to at least some extent (from a little to damp throughout) compared to only 11% of owner-occupied houses. Rental houses were also twice as likely to be deemed to smell musty compared to owner-occupied houses (Figure 21).

**Figure 21. Subjective measures of damp in the home recorded by the assessor. (Source: HCS 2015)**

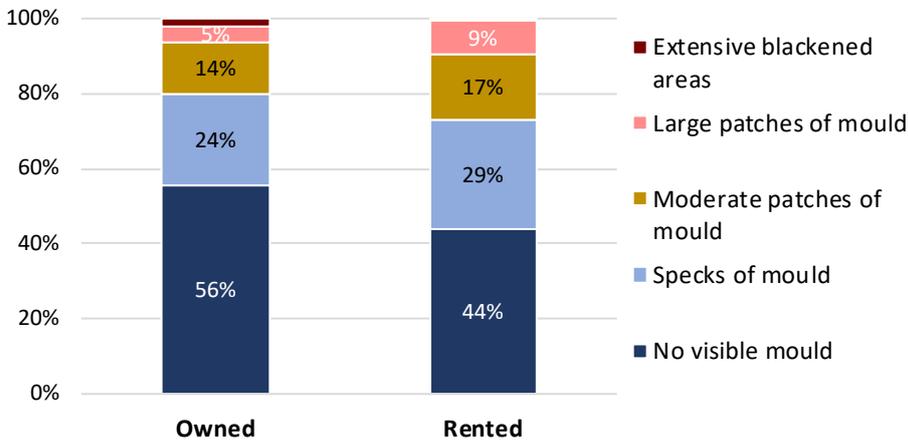
Whilst in most cases the most severe level of mould recorded was specks of mould, 17% of rentals had moderate patches and 9% had large patches (Figure 22). Furthermore, any visible mould could be an indication of the presence of harmful substances that pose health risks for household occupants.

Figure 22. Worst incidence of mould recorded anywhere in the house. (Source: HCS 2015)

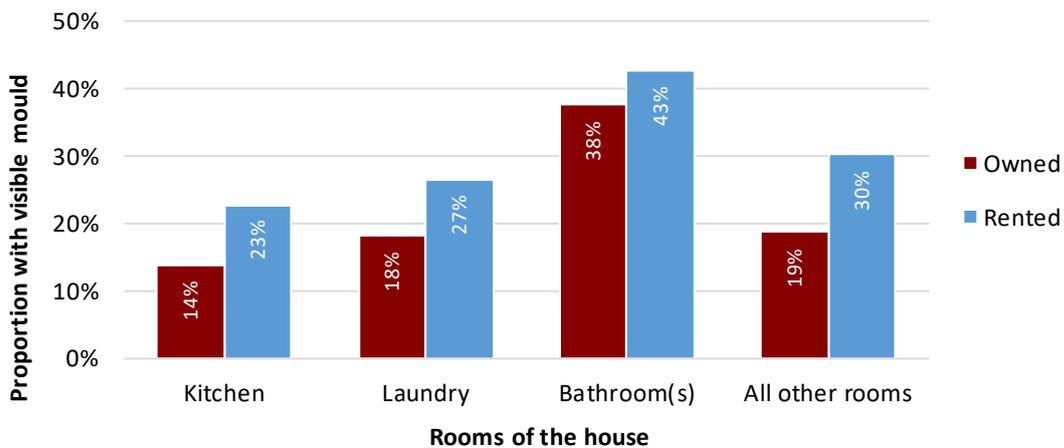
Figure 23. Mould visible in different areas of the house. (Source: HCS 2015)

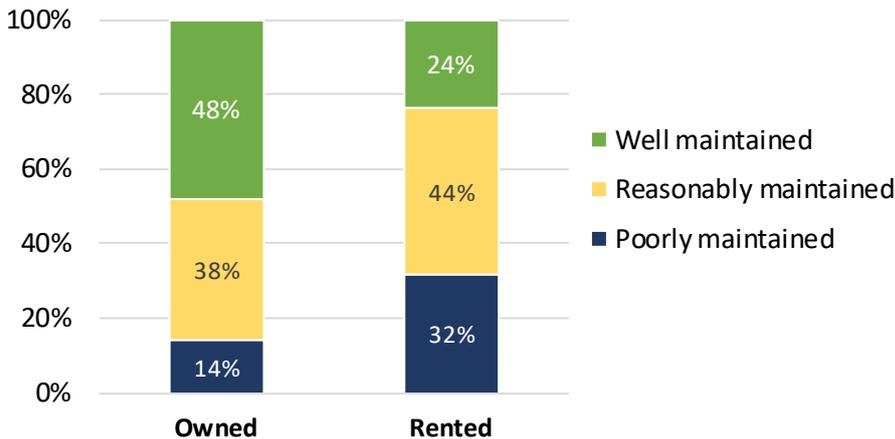
The final section of the HCS asks the assessor to make an overall assessment of how well maintained they considered the property. Figure 24 shows that 32% of rental properties were rated as poorly maintained, over double the proportion of owner-occupied houses. Owner-occupied houses were twice as likely to be considered well maintained than rental houses.

**Figure 24. Overall assessment of level of property maintenance. (Source: HCS 2015)**

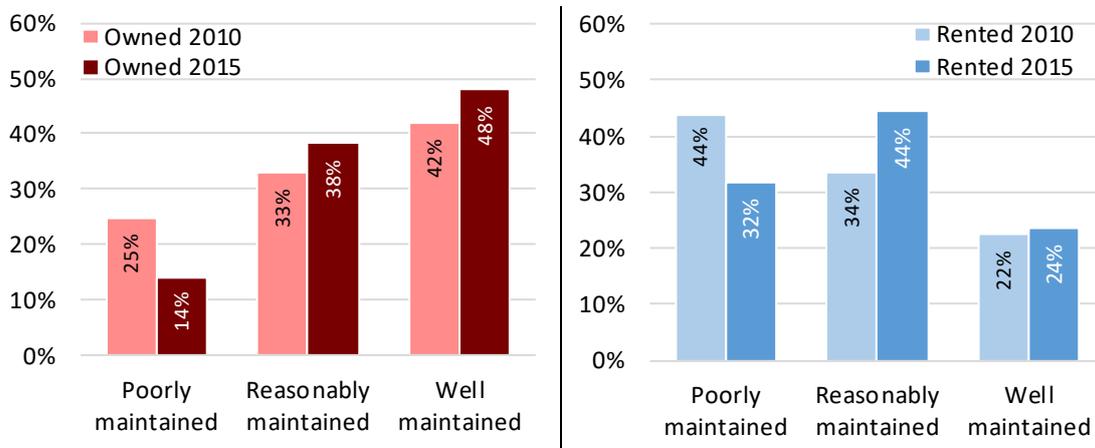
The measure of overall level of maintenance has been included in previous HCSs. Comparing the results over time can therefore give an indication of changes and trends in the maintenance of the New Zealand housing stock. A comparison with the 2010 HCS results suggests that there may be some movement towards improved levels of maintenance in both sectors. Proportionally fewer properties were rated as poorly maintained in 2015 and higher proportions were rated as reasonably and well maintained (Figure 25). However, this is just one measure of the condition of the housing stock amongst many data points recorded in the HCS. A more detailed comparison of 2015 survey results with previous HCS data is beyond the scope of this report but remains an area of further research and analysis for BRANZ.

**Figure 25. Changes in the overall surveyor-assessed level of maintenance of HCS houses from 2010 to 2015. (Source: HCS 2015 and HCS 2010)**
