# MADAGASCAR

## Build Back Better: Adapting Design

## PROJECT DESCRIPTION

## Different techniques adopted for houses on stilts:

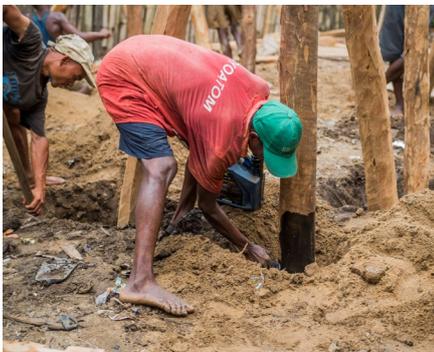
Hard woods are used for posts, dug 1 meter into the ground, and protected with a coating of motor oil.

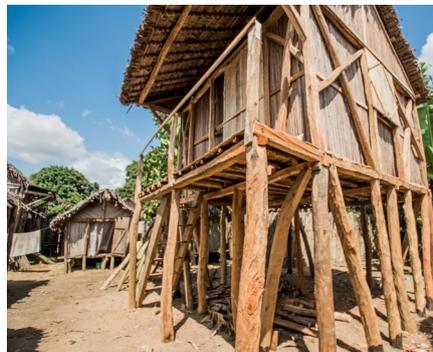
The stilts are reinforced with cross-bars on all sides.

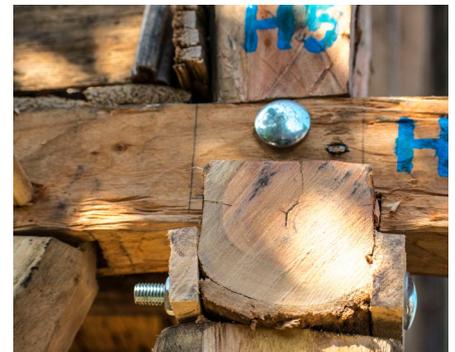
The connections of the four main stilts of the cross-bars that support the stilts of the superstructure are reinforced with bolts.

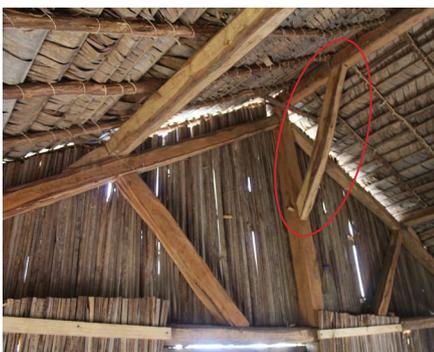
Wood trusses are reinforced with a diagonal bar attached to the top rafter.

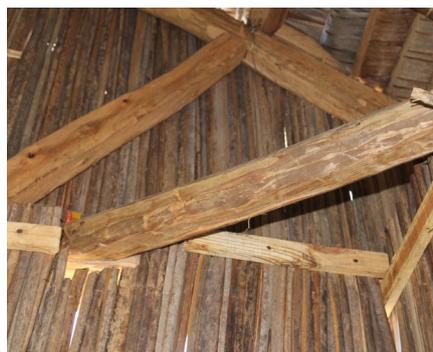
The top frame and beams are structurally stabilized by introducing horizontal reinforcement bars in the 4 top angles.

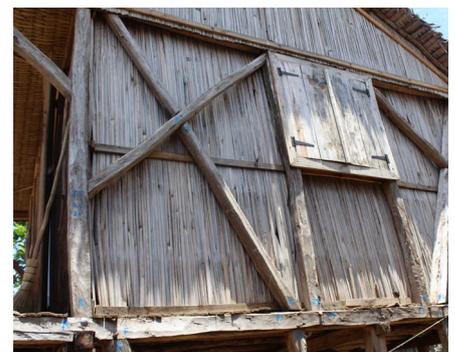
Diagonal bracing in all wall angles.

*"The various diagonal bracing techniques and the tie wiring are new to me, even if the quantity of wood is very similar and close to that used in conventional practice,"* says Jaonarison De L'Andrick, a carpenter.
