**Temporary Shelter for Refugees  
by  
Muiris Moynihan (CAI)**

**Fourth-year undergraduate project  
in Group D, 2006/2007**

## **Temporary Shelter for Refugees - Technical Abstract**

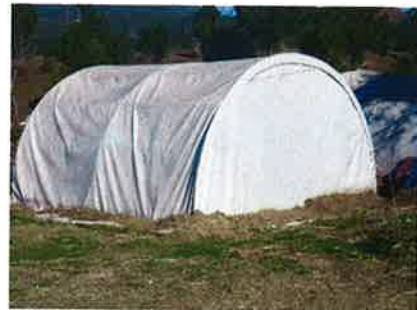
Figure 5: TRCS Tent

The 500 earthquake refugees lived in robust Turkish 'lighthouses', as they are termed. These are dome tents supplied by the Turkish Red Crescent Society (TRCS) which are extremely warm and well built – plastic sheeting is riveted to an aluminium frame. Along with the US Army tents (predictably robust and made to a high specification), these were the most waterproof and were sturdy in high wind, making them by far the most sought after shelters on site, although they were among the smallest.

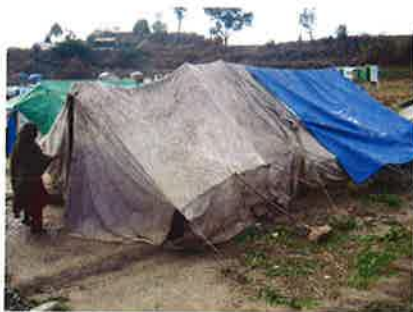
Figure 6: ILAP Tent

The rest of the camp population was sheltered in ILAP (International League Against Poverty) or IFRC (International Federation of the Red Cross) tents made from steel tubes and canvas. These are tension structures that leak profusely after a month, as once a tear forms it rapidly grows and is difficult to repair. The poles poke through the canvas to support it, a ready made water entry site, and the sides of the tent are poorly supported and face considerable wind load, hence rip extensively. The influx of water and constant damp made the interiors unhygienic, unsuitable for food storage and unbearable to live in after only 2-3 months.

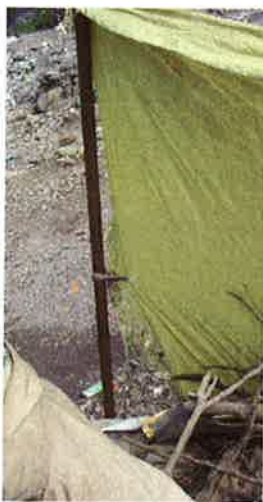
Figure 7: Tent pole as fence post

Most of the people were living in huts constructed from corrugated iron sheets, timber and canvas, usually with a dilapidated tent alongside as a storage area. Any tents were of the ILAP style and well over a year old, hence severely worn. All habitable tents had been extensively repaired. Even still they leaked profusely and blew over in storms, which broke some poles. These were replaced by wooden poles and the metal fragments left in piles. The hodgepodge shelters were somewhat better, but still miserable. Interestingly, none used spare iron poles as structural members; instead these were used as fence poles.

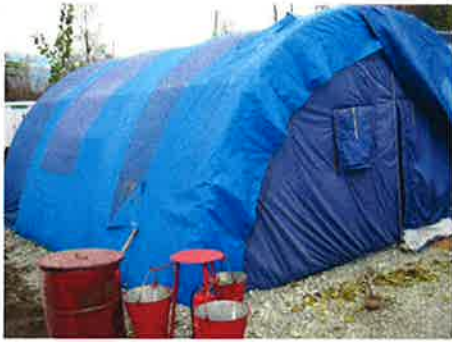
Figure 8: Mountain Tent

These people lived in sturdy hoop tents (either from the TRCS or of a very similar design) with 20mm CHS. Often ropes were tied between bars to further increase the stiffness but even still the tents sometimes deformed under snow loads (up to 4 feet in the depths of winter). In the worst snow storms the inhabitants had to brush the roof every 2 hours or risk collapse.

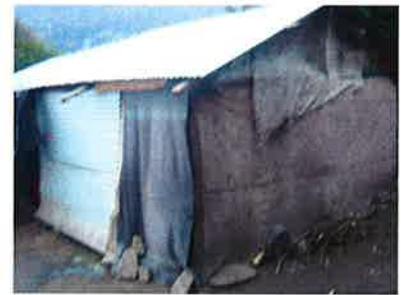
Figure 9: Newly built house

Much construction was going on in the mountains – water schemes, some reinforced concrete buildings (worryingly with no engineer and a lack of steel ties). Interestingly the communities often constructed huts by adding wooden planks and corrugated iron sheeting to tent frames, with successful outcomes. This disregarding of traditional housing methods (houses with a thick flat wood-&-clay roof and thin stone columns) was not witnessed elsewhere.

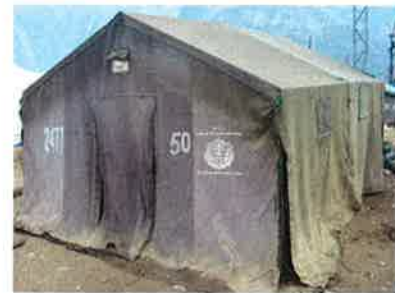
Figure 10: IDB Tent

That afternoon a tour was taken of two NRC camps with Rizwan Khan, Jonas' assistant. The first was for flood affectees, and had entirely house tents from the Islamic Development Bank (IDB). These were half a year old and in good shape, being relatively sturdy and waterproof. The next camp was populated by conflict refugees, who have lived in tents since partition. These refugees would only live in robust dome or house tents. They prepared the ground by levelling it, compacting it and laying gravel to promote water flow. Furthermore they placed pieces of corrugated iron in the sides and hung blankets along the roof to make it more hospitable.

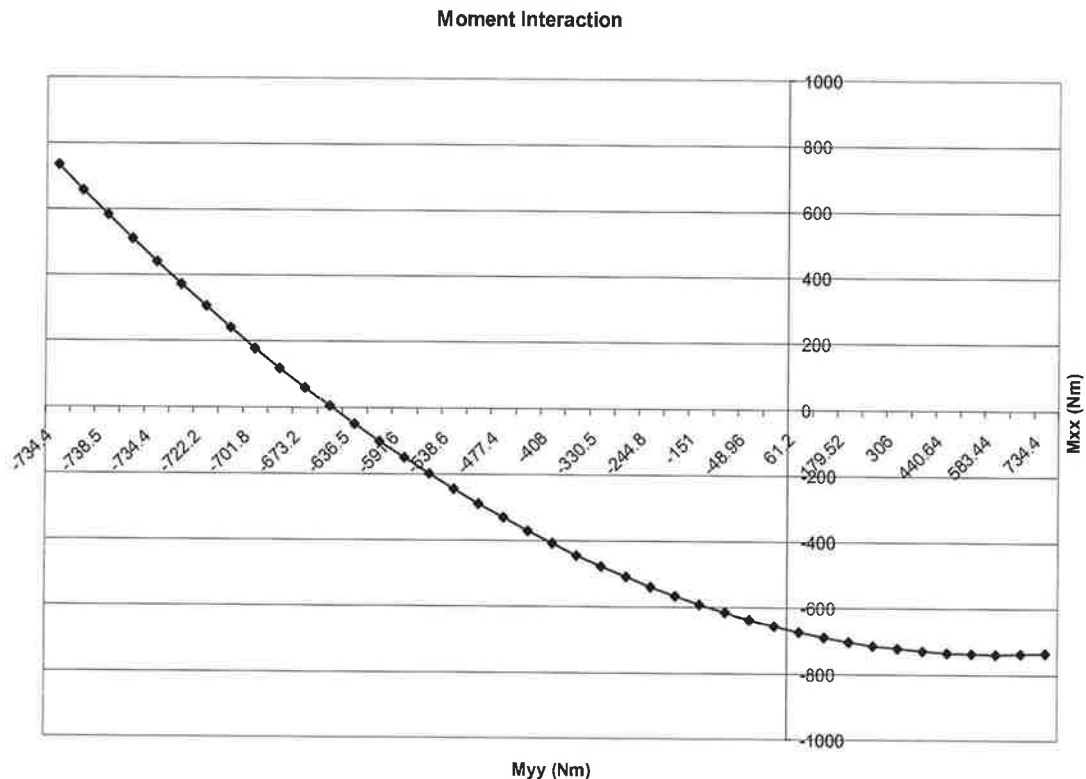
Figure 19: Moment Interaction Diagram for 40x40x4 Aluminium Angle

The moment capacity of the angles was then examined. To begin with the ultimate plastic moment of the section was found and compared with the moments generated in loading. The latter were not large as all the joints are pinned. Then it was realised that as moments were present in two directions, there would be interaction effects. An interaction diagram was derived (see Figure 19 below) and from this the moments were not found to cause failure.

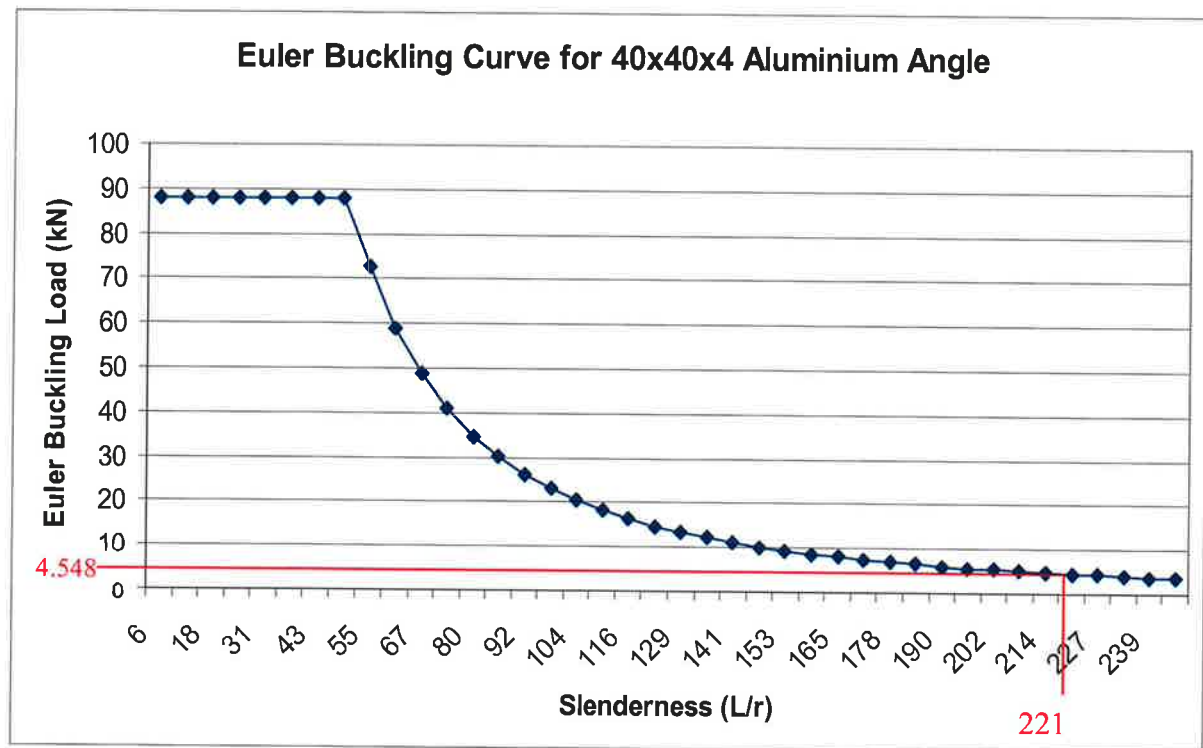
Figure 21: Euler Buckling Curve with Chosen Slenderness Marked

It was found that the effective length of the members needed to be 1m or a 40x40x4 section was required to prevent buckling. Adding further bracing was another option to prevent buckling. This was undesirable as it further cluttered the design and left more room for error in construction. Also the increased member section boosted strength and redundancy, but with the drawback of a 50% increase in weight. The Euler buckling curve for the 40x40x4 aluminium angle section is shown in Figure 21 overleaf.

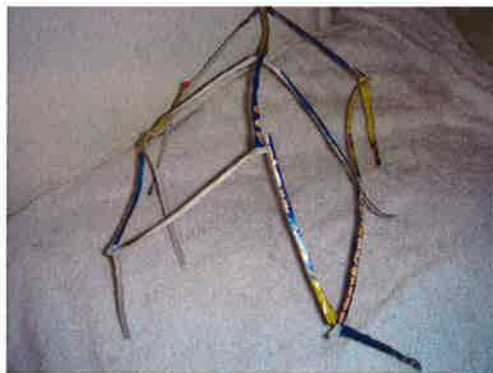
Figure 24: 1:10 Cardboard Model

The second cardboard model was a 1:10 scale model of the full tent (shown in Figure 24 below). It was made from thin cardboard stapled together and the main purpose was to show the overall configuration – how the angles needed to be oriented to best fit together. Furthermore it gave an idea of the relative dimensions, and together with the first model, it was fundamental in figuring out the roof apex joint, which did not carry much moment but was awkward and unobvious due to the geometry.

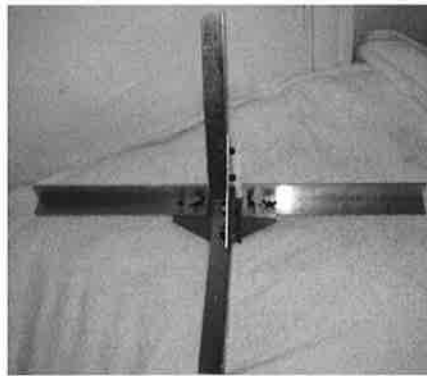
Figure 25: Second Aluminium Prototype

It was extremely useful in highlighting problems not considered/present in theory - small tolerances in the bolt holes allowed substantial rotation of the angles even when bolted in. In reality this could cause the tent to shake the bolts loose and fall to pieces in windy conditions and to prevent this more bolts spaced further apart were needed.

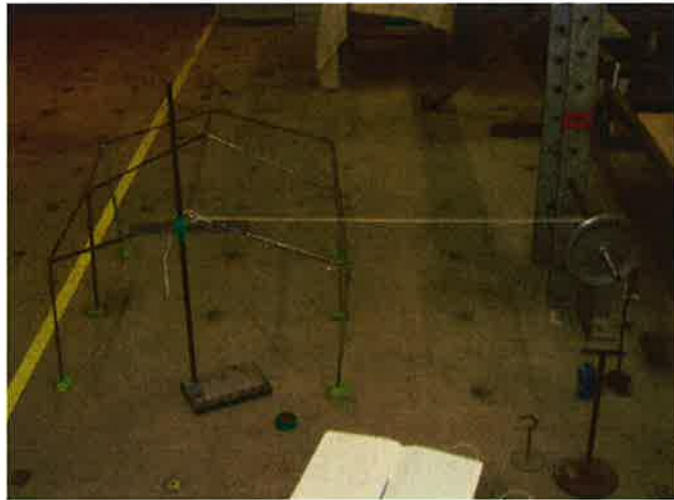
Figure 26: Experimental Set up

The prototype was tested by placing weights on a tray connected via a pulley to points on the frame, and using a ruler to measure deflection at those points (see Figure 26).

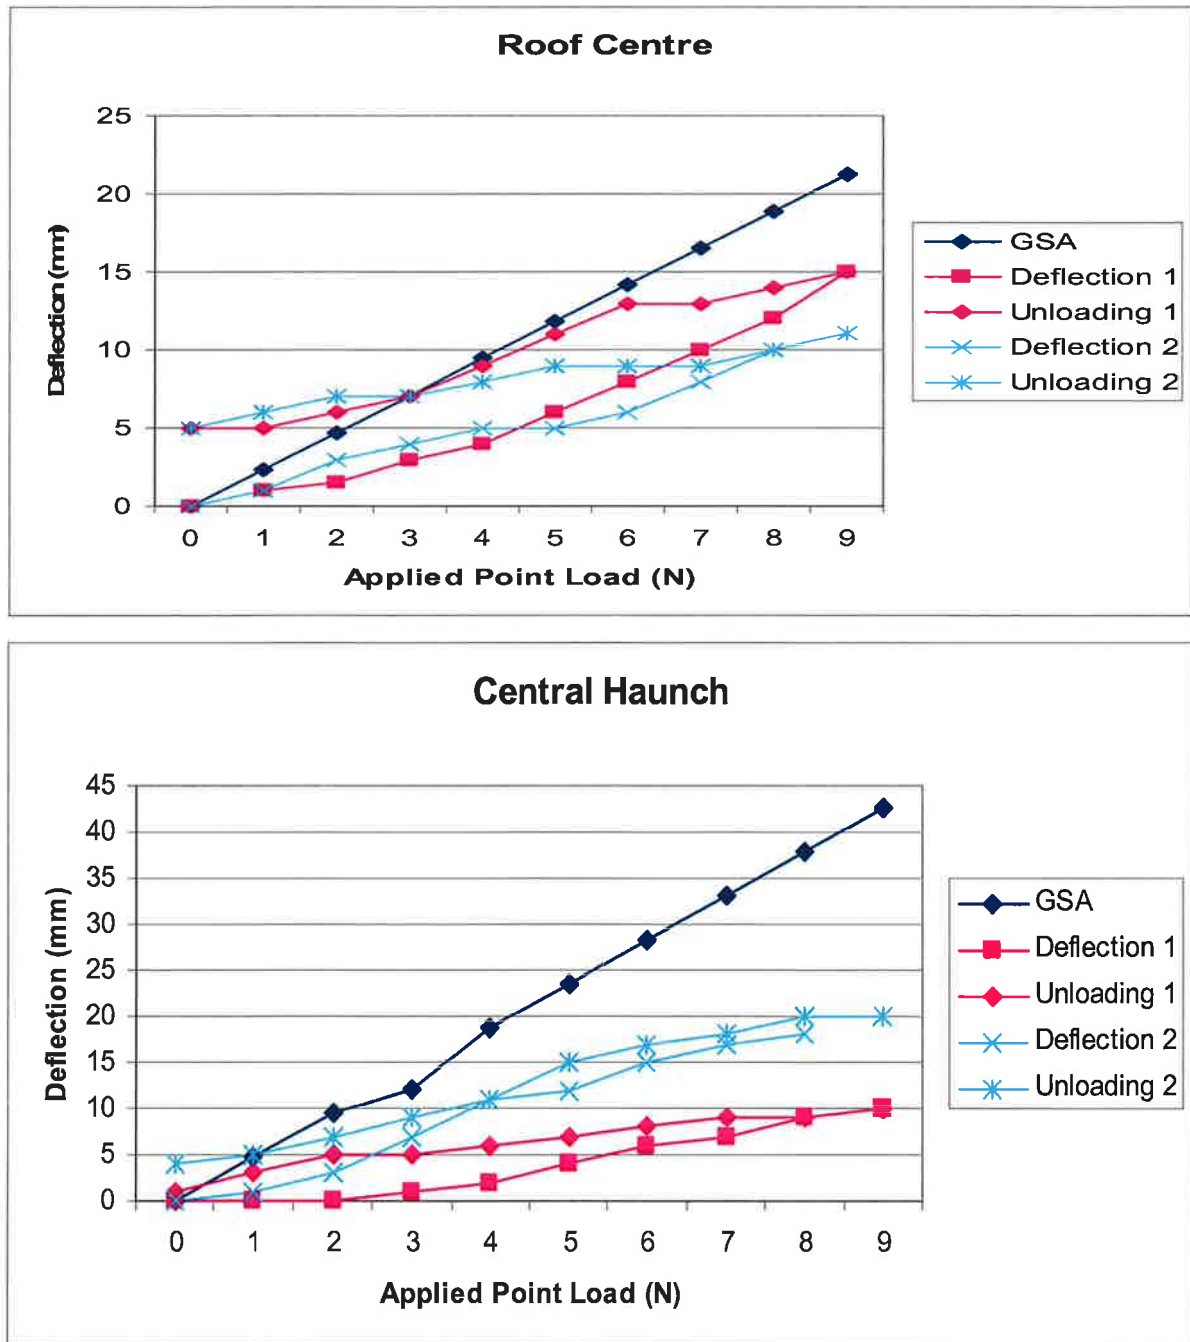
Figure 28: Load vs. Deflection Graphs from Experiment & GSA Analysis for Central Loading Points

The graphs of the results from the experiment are given below in Figures 28 & 29. Included in these graphs are the values calculated by GSA for displacement under the same loads.
