# EARTHQUAKE RESISTANT HOUSING

technical brief

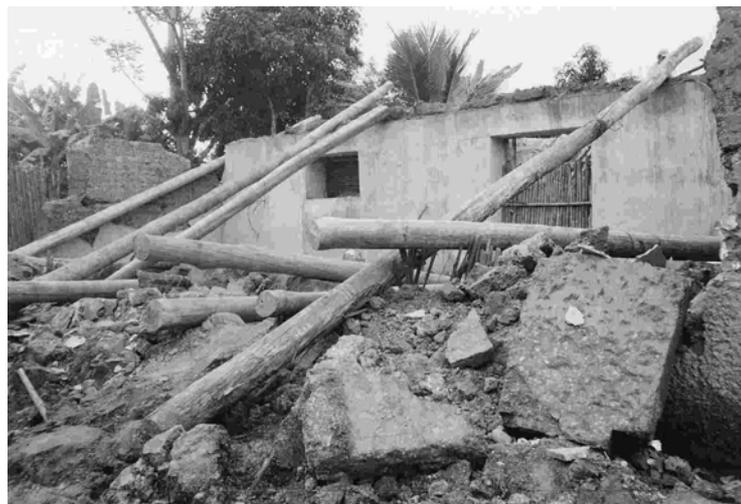
Figure 2: The impact of the earthquake on a tapial house in Soritor  
© Practical Action/Megan Lloyed-Laney

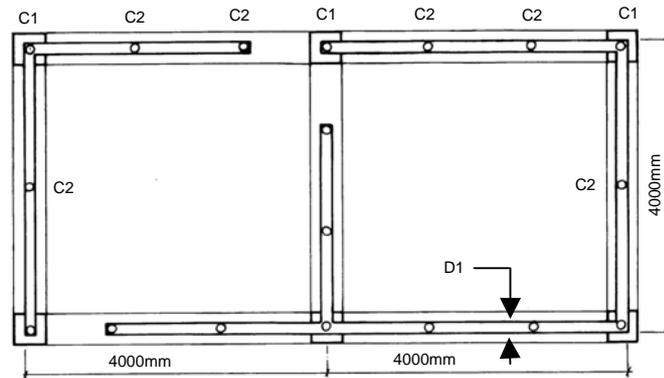
Figure 5: Plan view ©Practical Action /Duval Zambrano/J. Cuizano

include uniform measurements of 1.2m between structural columns which were made of square timber sections (200mm x 200mm).

Practical Action engineers drew on this academic research when presenting the improved technology to the men and women of Soritor. Technical details were soon adapted once Practical Action project engineers and technicians started work in Alto Mayo. For example, timber poles replaced the square columns as they are more readily available and do not require machinery or labour to process them from their raw state.

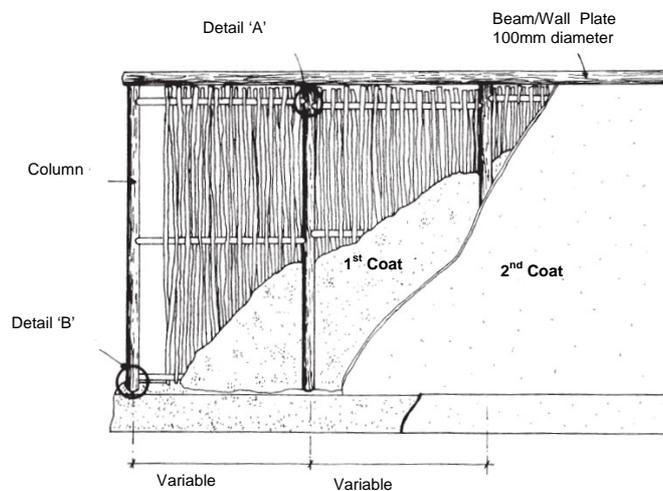
Figure 6: Wall construction ©Practical Action /Duval Zambrano/J. Cuizano

- concrete foundations to give greater stability.
- wooden columns treated with tar or pitch to protect against humidity, concreted into the ground with nails embedded in the wood at the base to give extra anchorage.
- use of concrete wall bases to prevent humidity affecting the wood and the canes in the walls.
- careful jointing between columns and beams to improve structural integrity.
- canes woven in a vertical fashion to provide greater stability.
- lightweight metal sheet roofing to reduce potential danger to occupants from falling tiles.
- nailing of roofing material to roof-beams; tying of beams and columns with roof wires to guard against strong winds and earth movements.
- roof eaves of sufficient width to ensure protection of walls against heavy rains.

Practical experience of working with this technology during the demonstration meant that Practical Action staff and members of the community were able to 'learn by doing'. This resulted in new thinking and some changes: for example, the first coat of plaster put onto the woven infill panels was found to crack, so rather than allow cracks to develop naturally, the first layer of plaster was deeply scored to allow for the shrinkage upon drying and to provide a better grip for the second coat of plaster.

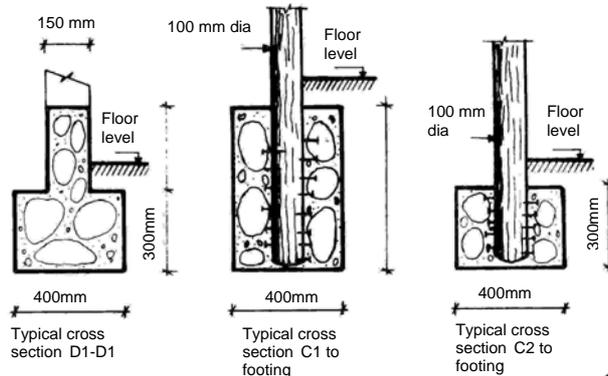
Figure 7: Details of the footings ©Practical Action /Duval Zambrano/J. Cuizano

**Specifications**  
 Concrete pad and strip foundations:  
 Mix – 1:10 (cement: aggregate)  
 +30 % large stones  
 Concrete wall base  
 Mix – 1: 8 (Cement: aggregate)  
 Wood is structural quality poles

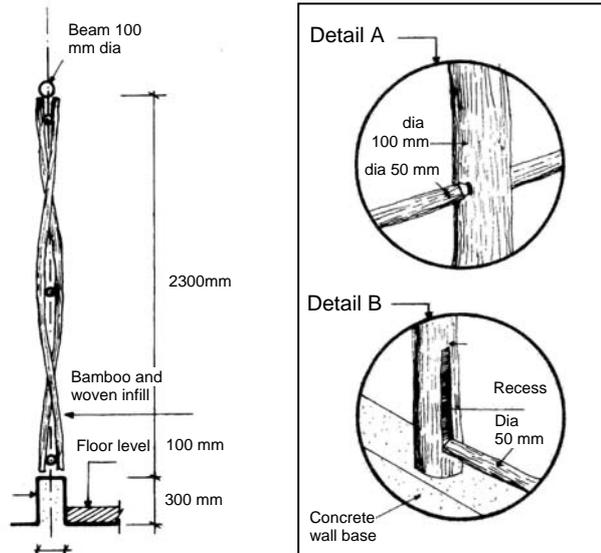
Figure 8: Cross section ©Practical Action /Duval Zambrano/J.

**Render**  
 1<sup>st</sup> coat – mud: straw  
 Mix – 100kg: 50kg  
 2<sup>nd</sup> coat – cement: lime: sand: or sieved soil  
 Mix – 1:1: 5  
 or cement: gypsum: sand  
 Mix – 1:1:5  
 \*ratios are by volume

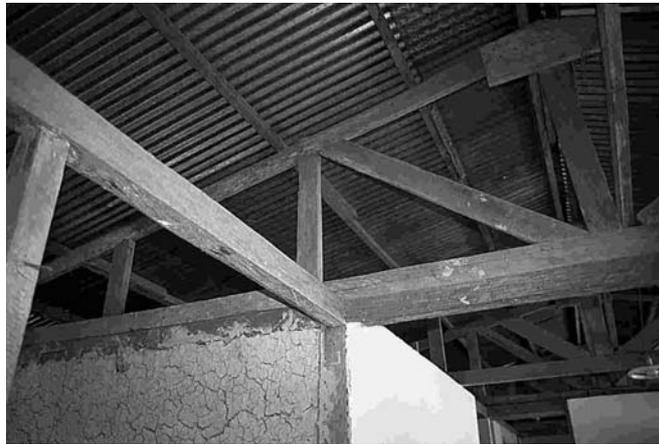
Figure 9: Careful jointing between columns and beams improves structural integrity ©Practical Action /Chris Martin

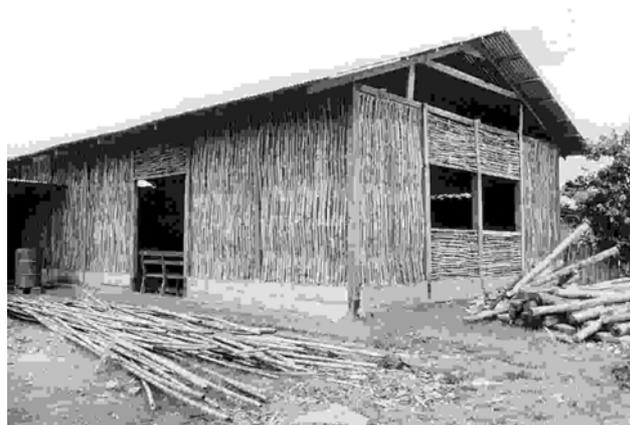
Figure 10: The Community building in Soritor during construction ©Practical Action /Rumi Velacliaga

After the initial project phase Practical Action planned to demonstrate improved quincha in a real project (seeing is sometimes believing). A community building was erected in central

Soritor. It took six months to build this structure, which resulted in this technology being nicknamed 'delayed quincha' rather than 'improved quincha'.

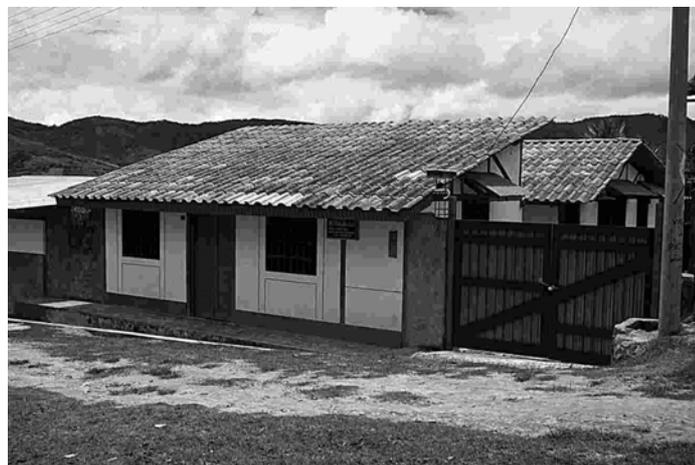
Figure 11: Improved quicha building in Jepelacio ©Practical Action /Lucky Lowe
